# Intel<sup>®</sup> Ethernet Controller I210

Specification Update

Revision 2.9  
332763-013

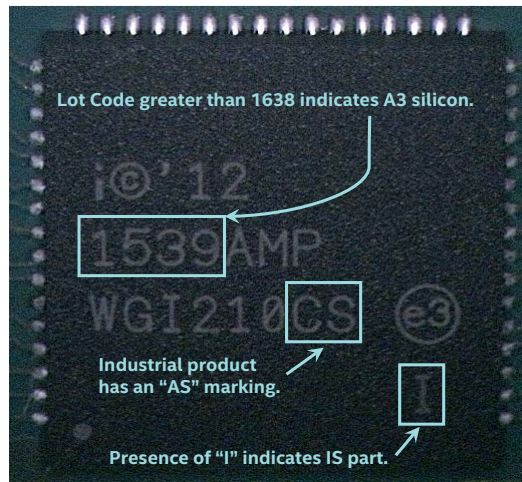
**Figure 1-1. Explanation of Top Markings for A3 Stepping**

The A3 stepping only applies to the Fiber (IS/CS/CL) products. The A3 stepping can be identified by the Fab Lot Trace Code marking on the package or by the iNVM contents.

- Fab Lot Trace Codes starting with 1638 or greater are A3 devices.
- Bit 1 of INVM\_DATA[61] (0x12214) is 1b on A3 devices.

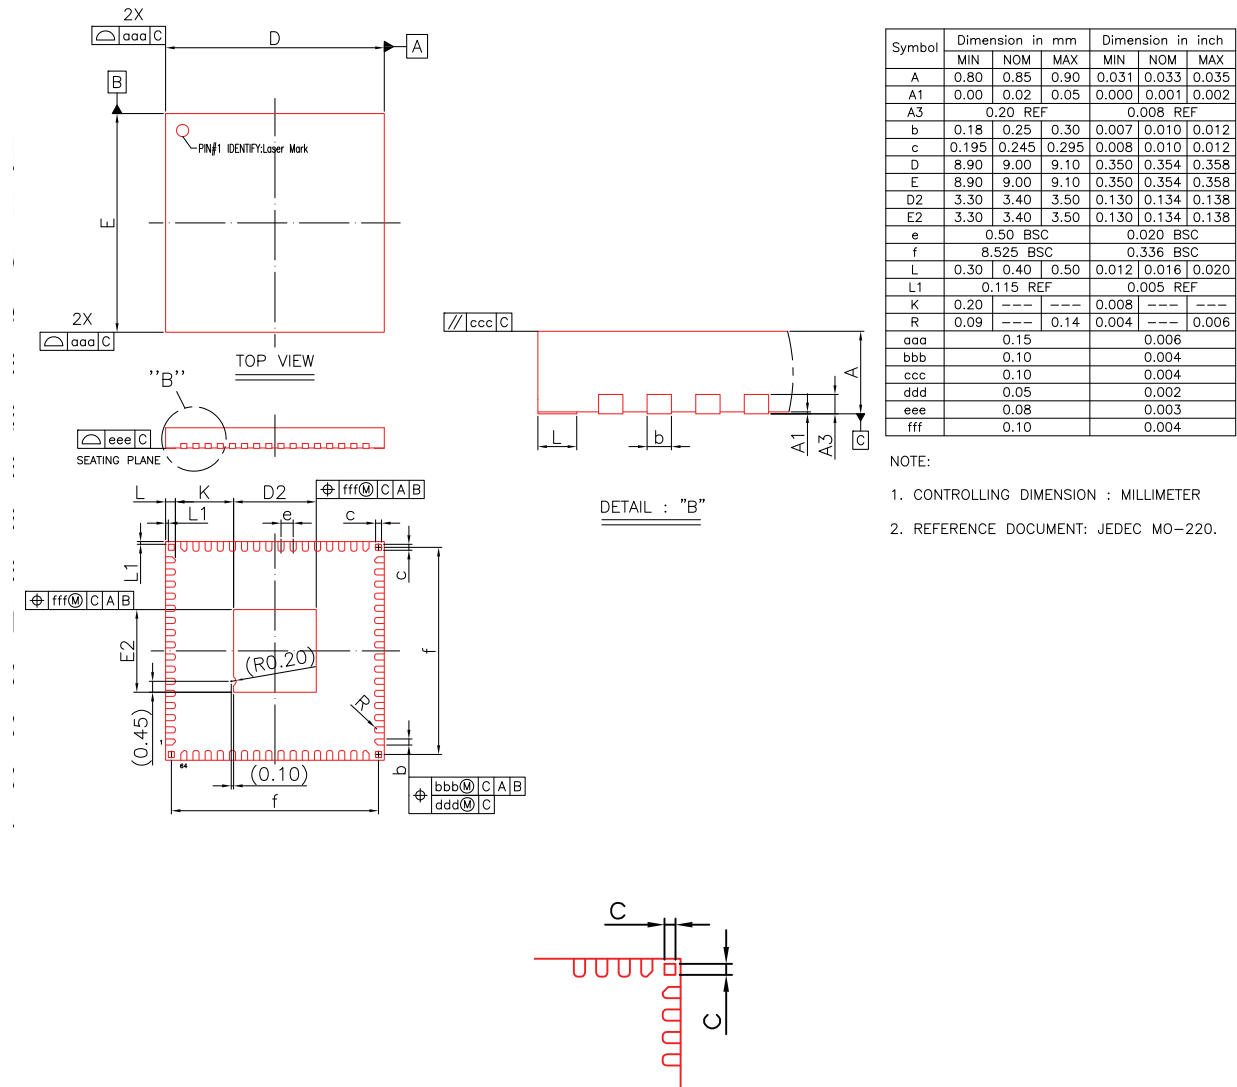
## 7. WGI210CS Automotive Industrial Temperature Fiber Schematic

**Note:** The I210 CS has four no-connect corner pads for added solder joint reliability (as shown in Detail C).
