# Intel<sup>®</sup> Communications Chipset 8900 Series

**Specification Update**

*June 2016*

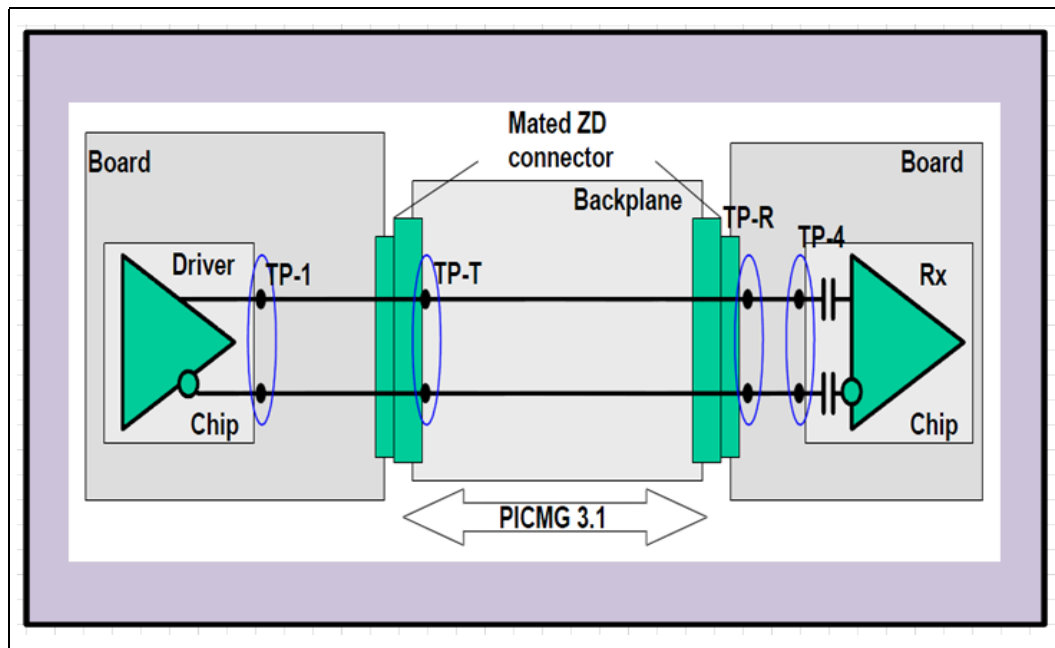
**Figure 2. 1000BASE-BX/FC-PI Transmitter Electrical Specifications**

### 75. GbE: GbE Interface Transmit Voltage Level Specification Violation

**Implication:** Although this is a specification violation, it does not affect the functional operation of the interface.

**Workaround:** Ensure that the signal routing length from TP-1 to TP-4 is greater than 10". Refer to *Intel® Communications Chipset 8900 Series Platform Design Guide (PDG)* for maximum routing length. (See Figure 2.)
