## MU9C8338/8358L Ethernet Filter Interface Errata Sheet

### AFFECTED DEVICES

MU9C8338 Revision C and MU9C8358L Revision A Ethernet Filter Interfaces.

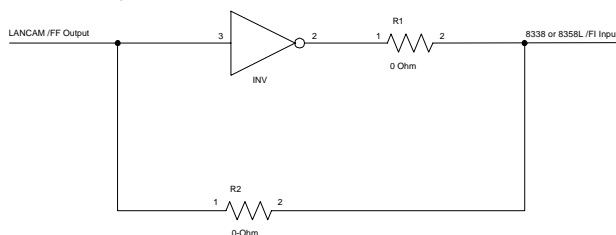
/FI input expects a 0 to 1 transition in order to cause the Full Flag interrupt, while the LANCAM /FF output goes from 1 to 0 when a CAM Full condition occurs.

Figure 1: LANCAM /FF Signal Inverter Workaround

MUSIC recommends that all designs requiring the Full Flag interrupt have an inverter placed between the /FF output and /FI input. If the inverter is obtained from logic other than a programmable logic device, a 0-Ohm bypass resistor is recommended so the PCB will be compatible with any later revisions. In the example shown in Figure 1, R1 is installed and R2 is omitted. If the inverter is not required and can not be removed from the PCB, resistor R1 can be omitted and R2 installed.
