82559ER Fast Ethernet PCI Controller

Stepping Information

October 2004

Revision 1.1

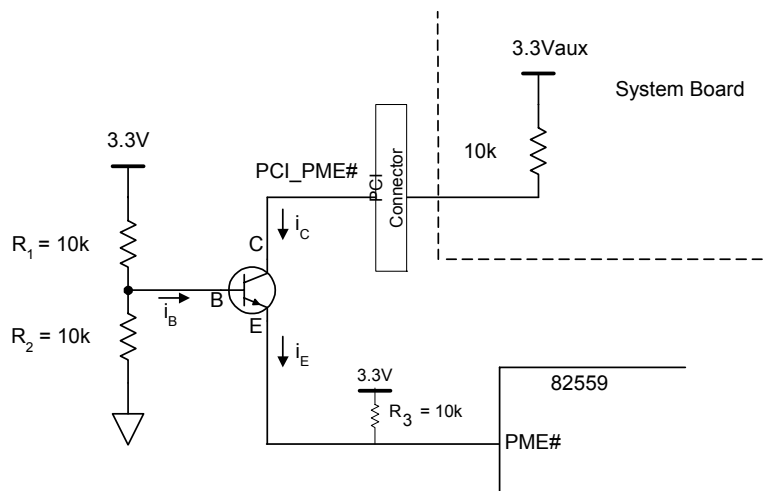
Problem: During power cycle events, the electrostatic discharge (ESD) elements internal to the 82559ER may falsely clamp the Power Management Event (PME) output signal to approximately 1.5 volts for 100 ms to 150 ms during initial power up. This can cause wake-up events to be recognized by the system if power management events are enabled in the system chipset. This may result in a problem for mobile environments since the false clamping can cause a suspended system to wake up when the power to the LAN device is transitioned.

Workaround: False PME indications can be avoided by disabling the recognition of a PME before removing or restoring power to the 82559ER. If a hardware solution is required, the following isolation circuit has been proven to be effective. The circuit requires the PCI PME signal (PCI_PME#) to be isolated from the 82559ER PME signal (PME#). The system does not see the 1.5 voltage level drop caused by the 82559ER's power transition.
