82540EM Gigabit Ethernet Controller Specification Update

October 10, 2005

The 82540EM Gigabit Ethernet Controller may contain design defects or errors known as errata that may cause the product to deviate from published specifications. Current characterized errata are documented in this Specification Update.

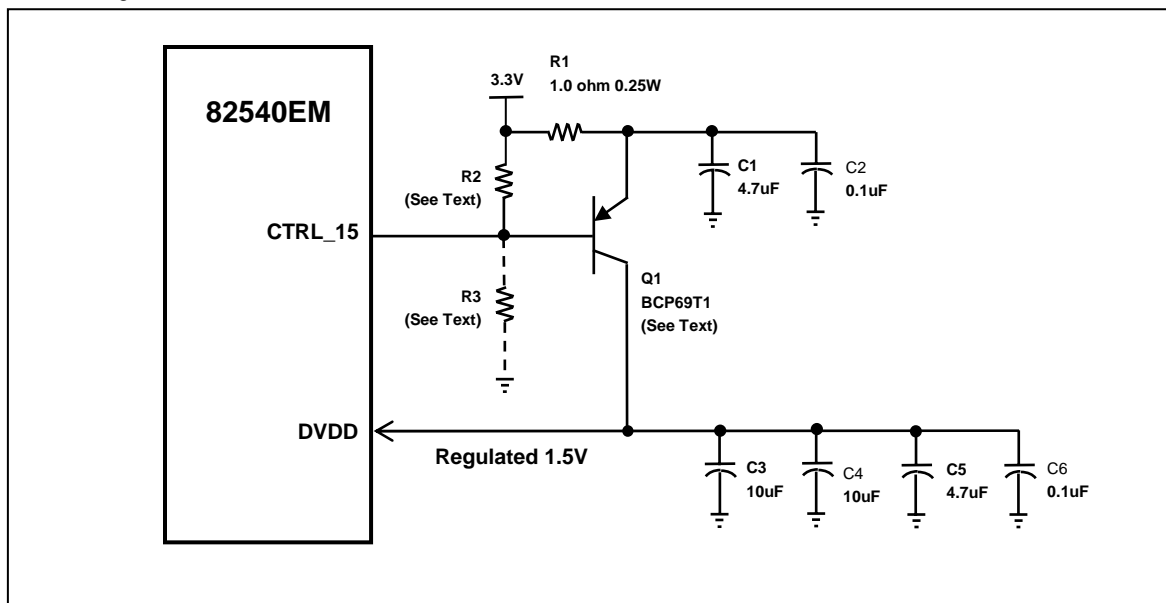
Implication: When drive is absent on the CTRL_15 output, only leakage current from the CTRL_15 output will be present. Depending on the amount of leakage current and the gain (Beta) of the external PNP transistor, there may be

When the 1.5V regulator control output fails, the 2.5V regulator control output(s) may also fail, driving the 2.5V supply toward either 0V or the 3.3V rail. The absence of one or both of the 1.5V and/or 2.5V supplies prevents the Ethernet controller from operating correctly.

Workaround: Refer to the figure below. The regulator control output is Ball P11 on the 82540EM controller. Intel's original reference designs showed two external resistors, R1 and R2, in this circuit. The workaround is to completely remove R2 (shown in reference schematics as 5.1K) and place another resistor, R3, to connect between the CTRL_15 output and ground, in order to create additional base current and ensure sufficient collector current is generated.

Due to variations in PNP minimum/maximum transistor gain, this circuit must adhere to specific requirements for the PNP transistor, R3 resistor value, and configuration of the 82540EM controller. Follow **workaround instructions** in Technical Advisory TA-147, "Possibility of 1.5 Voltage Regulator Failures on 82540EM LOM Designs." **Special Note:** Workarounds differ among the 82540EM, 82545EM and 82546EB controllers and each controller has a separate technical advisory.

Systems that generate 1.5V without using the Ethernet controller's onboard regulator control (at a central power supply, for example) do not need a workaround. No changes are required for the 2.5V regulator circuit.
