82540EP Gigabit Ethernet Controller Specification Update

October 10, 2005

The 82540EP Gigabit Ethernet Controller may contain design defects or errors known as errata that may cause the product to deviate from published specifications. Current characterized errata are documented in this Specification Update.

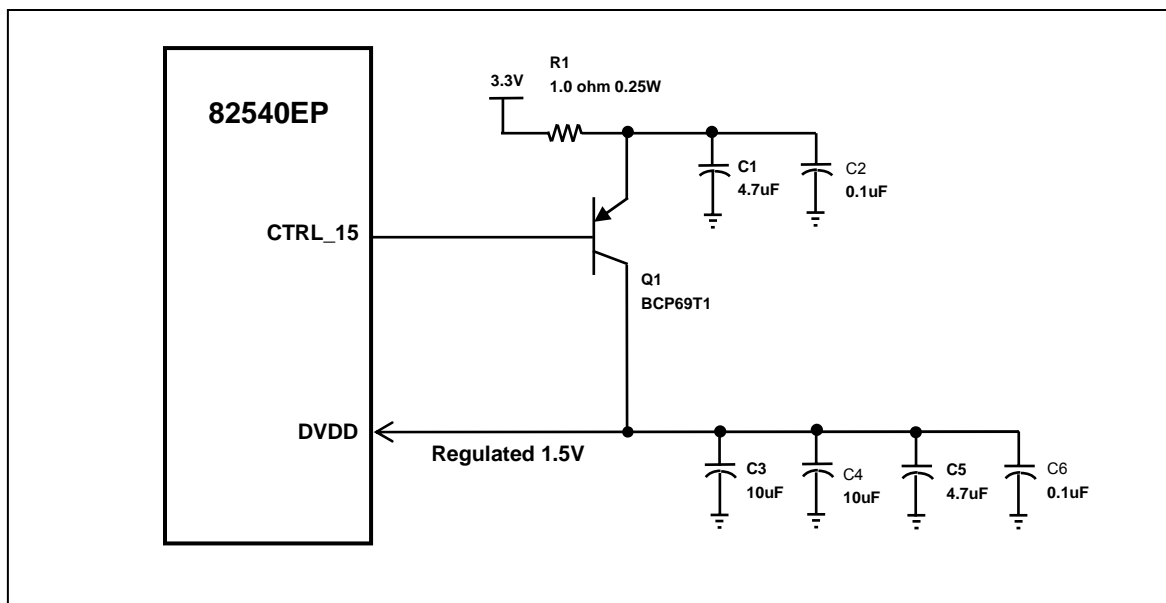
1. 1.5V Regulator Control Circuit

Problem: The 82540EP product contains on-chip LDO voltage regulation controllers for both 1.5V and 2.5V. The 1.5V regulator control output is Ball P11 on the 82540EP controller, and may be optionally used to drive an external PNP pass transistor as shown in the figure below.

The earlier 82540EM Gigabit Ethernet Controller contains an erratum which causes the 1.5V regulator control circuit to possibly start up incorrectly. Workarounds involved the use of a resistor attached to the transistor base, replacing the transistor with a similar model carrying tighter gain specifications, enabling the SMBus, and/or adding a second transistor. The 82540EP controller will work properly in a system containing a recommended workaround for the 82540EM device **as long as the workaround is implemented in its entirety**.

The 82540EP controller does not require any additional workaround, however, and may be applied using the circuit below:

Note that the 82540EP also contains a “Maximum Power-Savings” mode to permit applications to reduce D3 no-wakeup power consumption. However, if “Maximum Power Savings” is utilized, then the on-chip LDO regulation circuits cannot be used, and power must be supplied via external voltage regulation.
