Intel® 82566 Gigabit Platform LAN Connect

Specification Update

January 2012

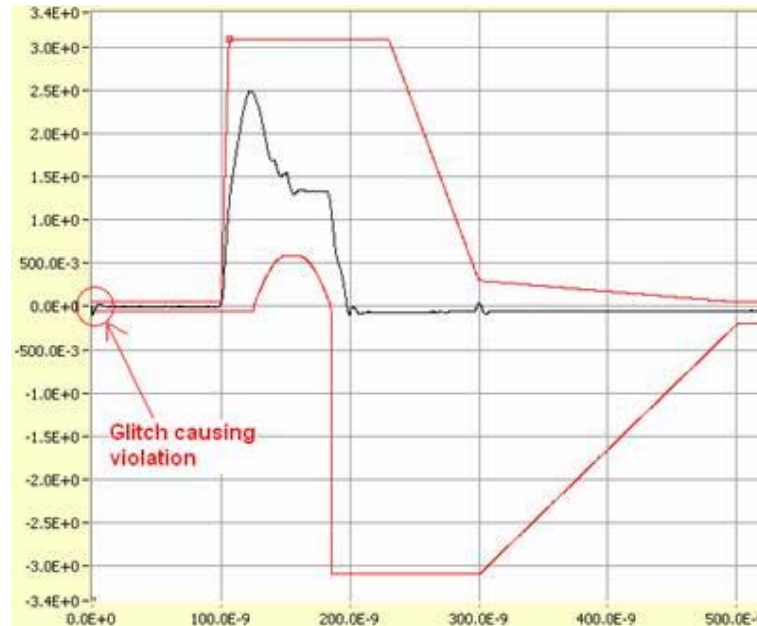
Figure 2. TP_IDLE Silence Duration and Silence Voltage Template Mask

Problem: The 10BASE-T link pulse waveform touches the template mask due to a small voltage glitch, as measured per the TP_IDLE silence duration and silence voltage test (IEEE 10 Mb test case ID 1411.01.06).

Implication: IEEE conformance is marginal. There is no impact to system level performance. This issue only occurs during 10 Mb Idle Mode. The voltage glitch occurs because the 82566, by default, powers down the transmitter between link pulses (during the 0V output period) to save power. The glitch is visible slightly before the transmission of the link pulse.

Workaround: The workaround prevents transmitter power-down during silence periods. This workaround increases the power consumption of the 82566 ~180mW during 10 Mb idle mode. Customers that desire to implement this workaround should contact their Intel representative for more information.

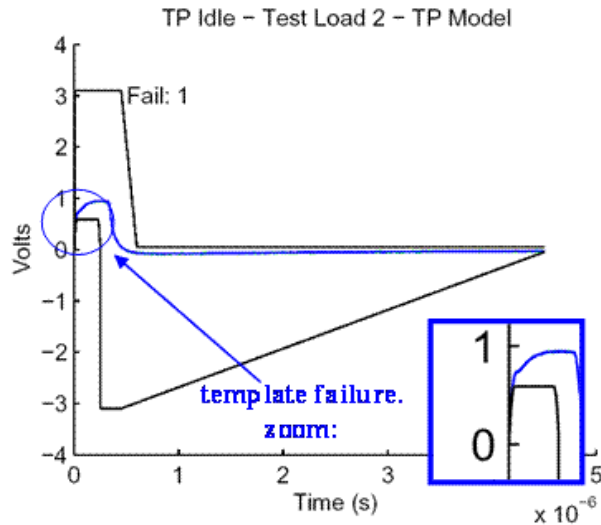
Figure 3. Typical Scope Measurement of TP Idle with Test Load 2

Problem: The 10BASE-T TP_IDL waveform touches the template mask when tested with twisted-pair model combined with test load 2, per IEEE test case 1411.10.06. There is no issue with the other test loads.

Implication: Per the IEEE specification, the TP_IDL pulse must fit into a template when measured with and without the twisted-pair model for two types of loads (load1 and load2). The combination of the twisted-pair model together with load2 is the challenging one because the waveform is the most attenuated. Some test conditions and methodologies do not apply averaging during the waveform measurement (see non-averaged waveform in Figure 4) and might show marginal IEEE conformance. There is no impact in system level performance.

Workaround: There is currently no workaround.

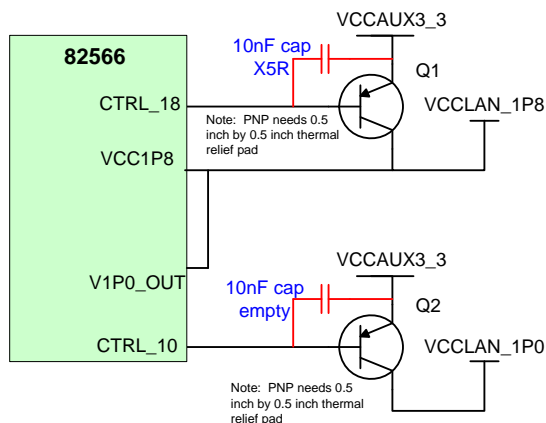
Figure 5. IVRD Implementation

Problem: The 82566 internal LVR controller, when used, creates excessive noise on the LAN 1.8V power supply.

Implication: In some platforms, excess noise has been seen on the LAN 1.8V supply when using the 82566 internal voltage regulator controllers. The issue was observed in both the IVRI and the IVRD modes. The LAN 1.8V noise might feedback into the 3.3V supply as well. This noise could affect the 82566’s ability to meet IEEE specifications.

Workaround: Add a 10 nF cap as shown in Figure 5 and Figure 6. Intel also recommends adding a stuffing option for a 10 nF capacitor (marked do not populate) to the 1.0V linear regulator when in IVRD mode.
