# **Intel<sup>®</sup> Ethernet Controller 82571EB/82572EI/82571GB/ 82571GI Specification Update**

**Networking Division (ND)**

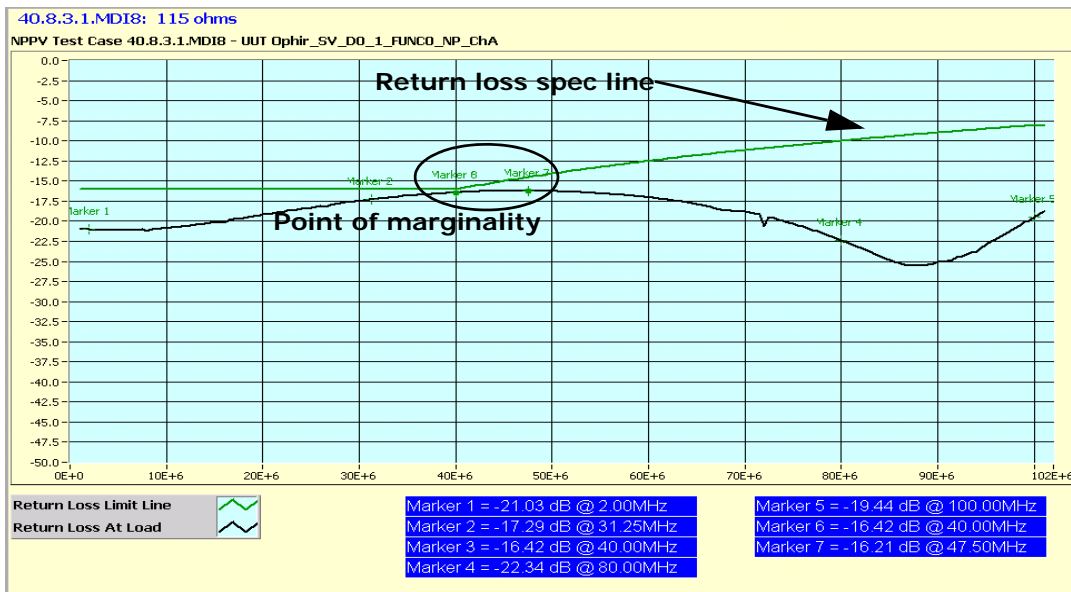
Return loss for 115 ohm load is marginal (Gigabit IEEE specification Section 40.8.3.1) near the frequency of 40MHz. Return loss is acceptable throughout the rest of the frequency spectrum and conforms to the 10Base-T and 100Base-TX specification limits.

IEEE conformance is marginal. There is no impact on system-level performance.
