Intel[®] Ethernet Switch FM10000

Specification Update

May 2016

Revision 2.0
334304-001

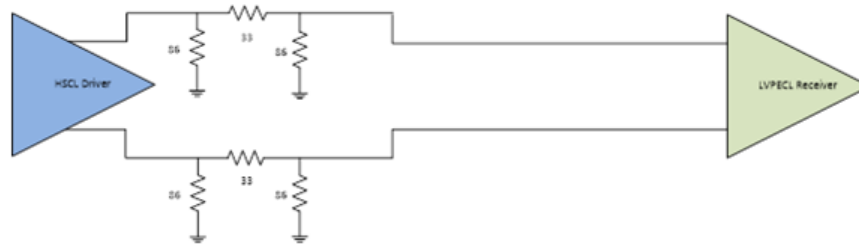
Some customers may decide to use HSCL transmitters in place of LVPECL transmitters. Using an HSCL driver may be possible using a circuit similar to the diagram below. Be aware that Intel has not validated this circuit with the FM10000.

Intel strongly recommends that customers drive the LVPECL receivers on the FM10000 with LVPECL transmitters. FM10000 validation was performed with LVPECL driving LVPECL.

Customers should review the Ruby Rapids and Red Gorge reference design schematics for other potential circuits.

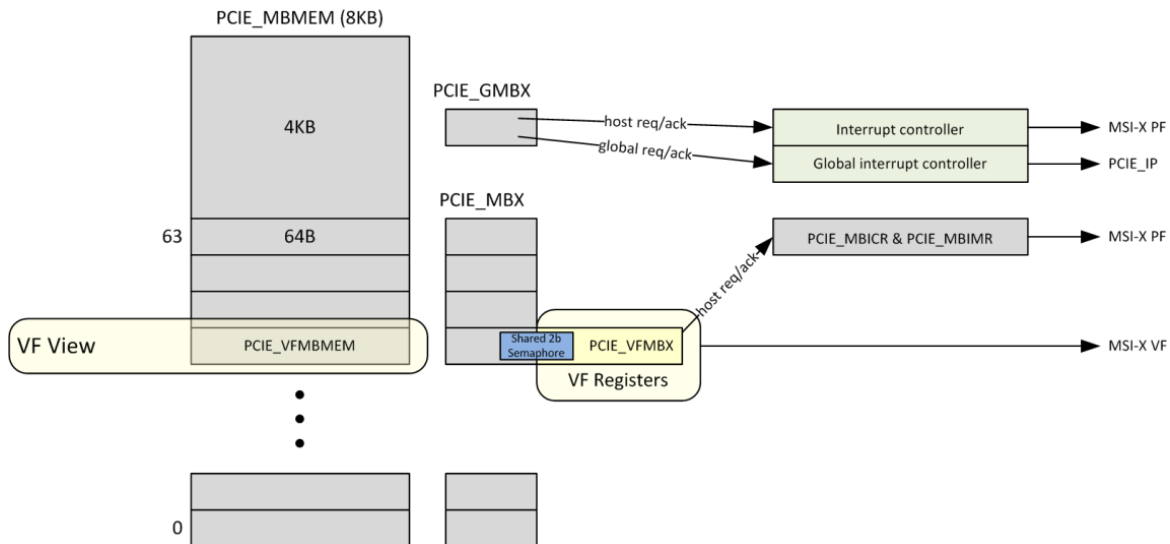
Figure 2-1 PCIe Mailbox Unit

The mailbox control registers cannot be written without modifying the semaphore owner bit. Original definition defined the owner bit stay unchanged if written as zero. Furthermore, writing zero to this bit clears the bit instead.

Unable to use mailbox semaphore mechanism.

Since the mailbox control register requires it be written from time to time for consuming messages or for changing the enable interrupt setting, the following workaround flow is recommended. Instead of using semaphores, the proposed workaround uses a lockless mechanism. It splits the mailbox memory in two half regions, each half written by one different entity.
