87C196JR SPECIFICATION UPDATE

Release Date: December, 1998

Order Number: 272858-005

The 87C196JR may contain design defects or errors known as errata. Characterized errata that may cause the 87C196JR's behavior to deviate from published specifications are documented in this specification update.

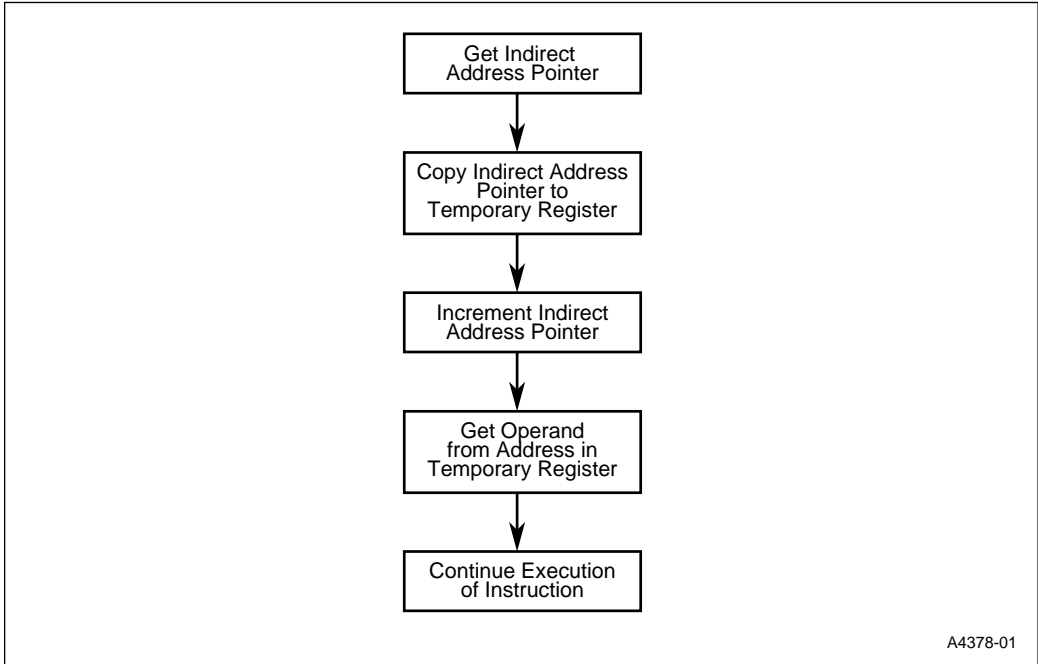
8. *Indirect Addressing With AutoIncrement*

PROBLEM: For indirect addressing with autoincrement, a pointer that points to itself results in an access to the incremented pointer address rather than the original pointer address.

The CPU stores the pointer's value in a temporary register, increments the pointer, then accesses the operand at the address contained in the temporary register, as shown in this flowchart.

Therefore, if the pointer points to itself, the CPU accesses the operand at the incremented address contained in the pointer.

WORKAROUND: Avoid using an indirect address pointer that points to itself.

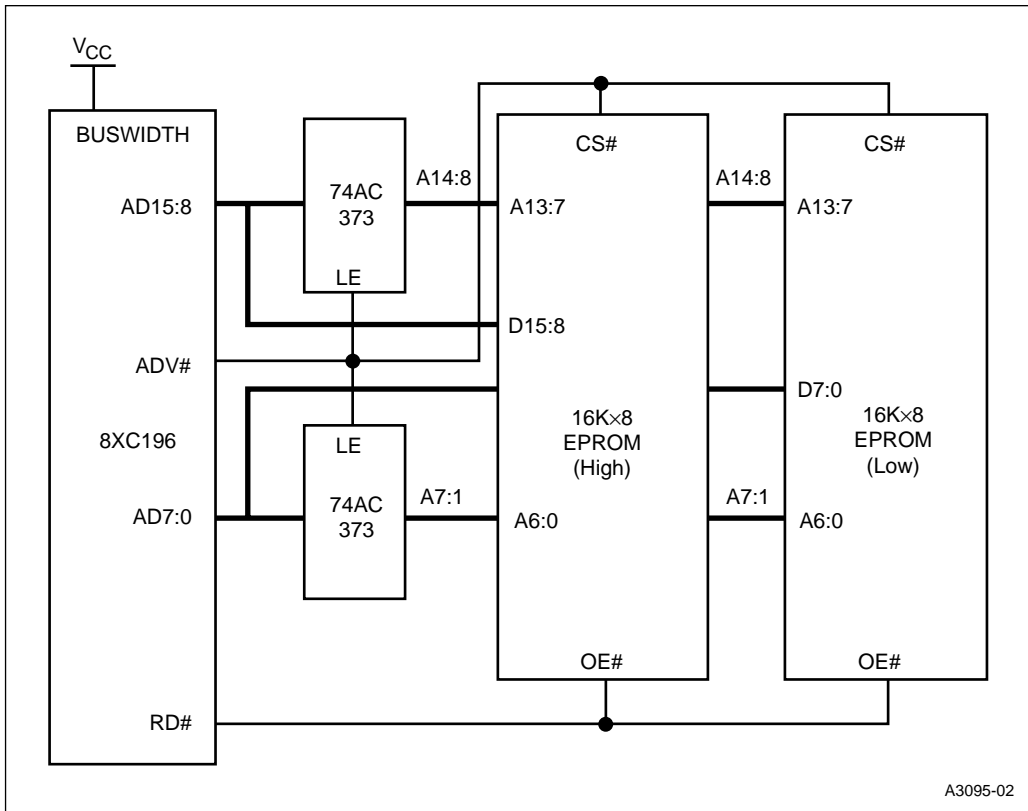
Figure 1. 16-bit System with EPROM

1. **High address inputs to the low EPROM should be A14:8 in Figure 15-18.**

ITEM: The next revision of the user's manual will include the following corrected graphic.
