# 87C196JT 20 MHz Specification Update

Automotive

*December 1998*

Order Number: **272859-006**

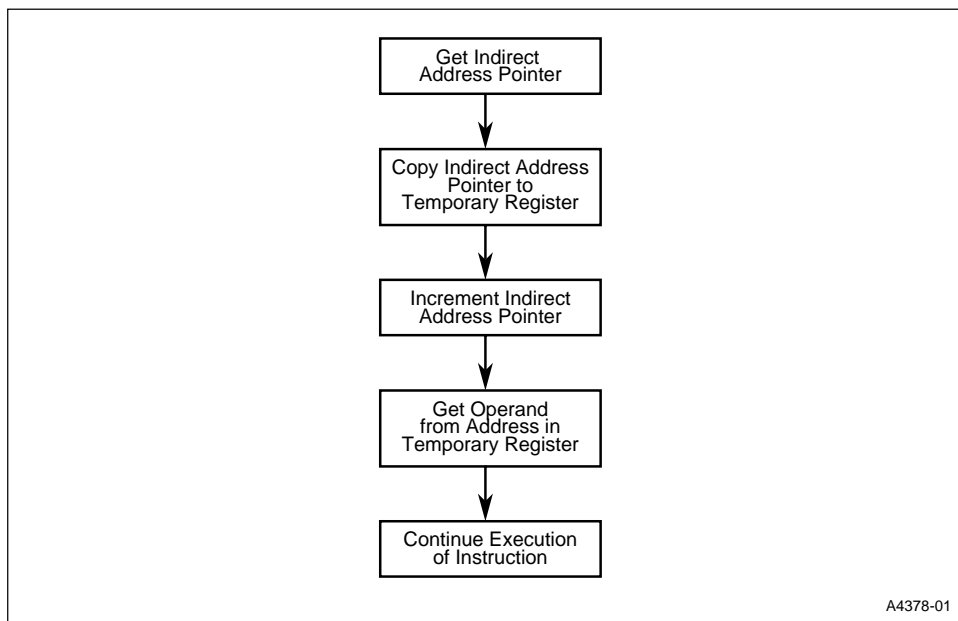
## 8. Indirect Addressing With AutoIncrement

**Problem:** For indirect addressing with autoincrement, a pointer that points to itself results in an access to the incremented pointer address rather than the original pointer address.

The CPU stores the pointer's value in a temporary register, increments the pointer, then accesses the operand at the address contained in the temporary register, as shown in this flowchart.

Therefore, if the pointer points to itself, the CPU accesses the operand at the incremented address contained in the pointer.

**Workaround:** Avoid using an indirect address pointer that points to itself.

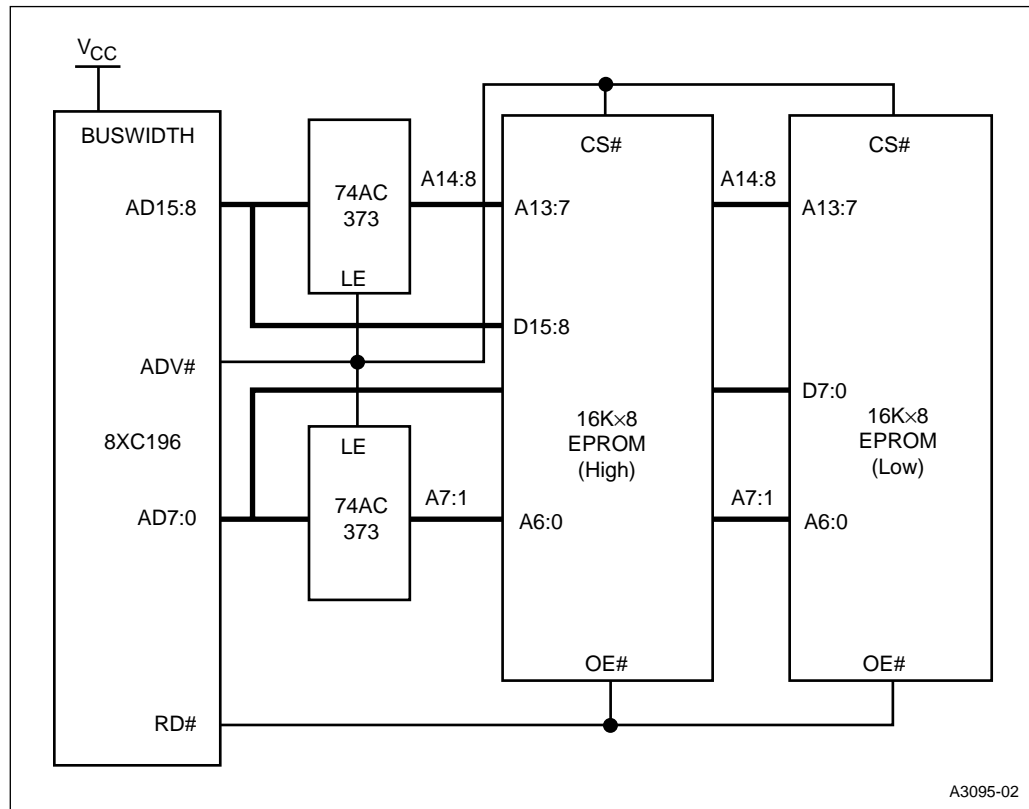
**Figure 1. 16-bit System with EPROM**

**1. High address inputs to the low EPROM should be A14:8 in Figure 15-18**

**Issue:** The next revision of the user’s manual will include the following corrected graphic.
