80C186XL/80C188XL EMBEDDED MICROPROCESSORS SPECIFICATION UPDATE

Release Date: June, 1997
Order Number: 272895.002

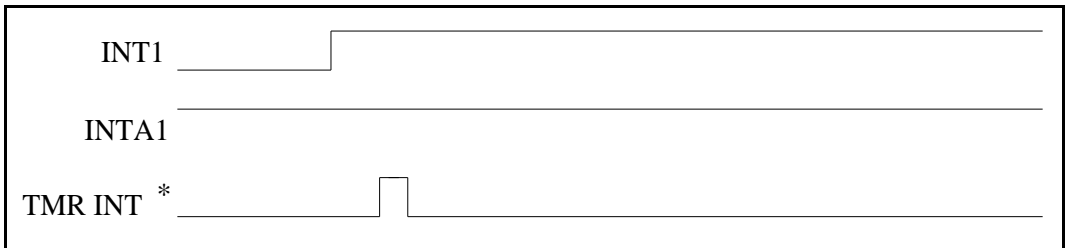
Figure 2. Incorrect INT1 Acknowledge Sequence with Higher Priority Timer Interrupt

The errata occurs when a higher priority interrupt occurs between INT1 and its expected acknowledge. The processor completes internal interrupt acknowledge cycles as seen on the status lines but no acknowledge cycle is sent on the INTA1# output (Figure 2).

*Note: This interrupt could be any of the following: DMA, Timers, Serial, INT0, or INT2.

CONDITION	WORKAROUND
1. Only INT1 is configured in cascade mode and is lower priority than at least one other interrupt.	Use only INT0 in cascade mode instead, or make INT1 the highest priority interrupt, or use hardware workaround.
2. INT1 and INT0 are both in cascade mode.	Use only one interrupt in cascade mode, or use hardware workaround.
3. Only INT0 is configured in cascade mode and is lower priority than INT1.	Make INT0 higher priority than INT1, or use hardware workaround.

1. Pull data bus lines 0 to 7 to a known value (using pull-up resistors) to force a defined value on the bus when the errata occurs.

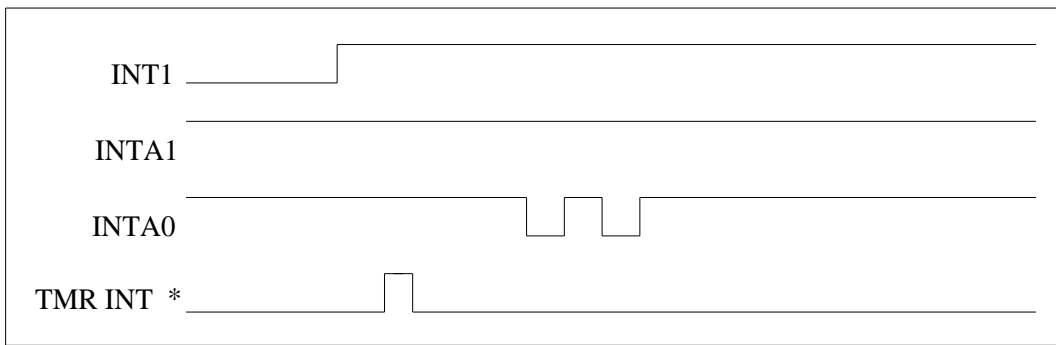
Figure 3. INT0 And INT1 Acknowledge Failure Due to Higher Priority Timer Interrupt

If INT0 and INT1 are configured in cascade mode and a higher priority interrupt occurs between INT1 and its expected acknowledge, then the acknowledge will appear on INTA0# instead (Figure 3).

*Note: This interrupt could be any of the following: DMA, Timers, Serial, or INT0.

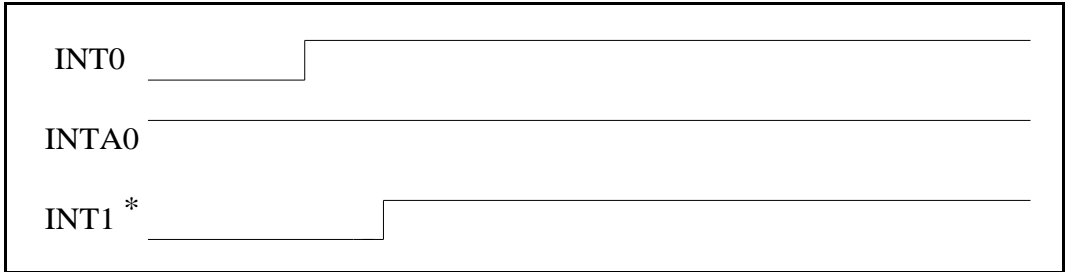
Figure 5. Incorrect INT0 Acknowledge Operation with a Simultaneous INT1

The errata occurs when INT1, which is higher priority than INT0, occurs between INT0 and its expected acknowledge. The processor completes internal interrupt acknowledge cycles as seen on the status lines but no acknowledge cycle is sent on the INTA0# output (Figure 5).

*Note: This problem occurs only if INT1 is higher priority than INT0.

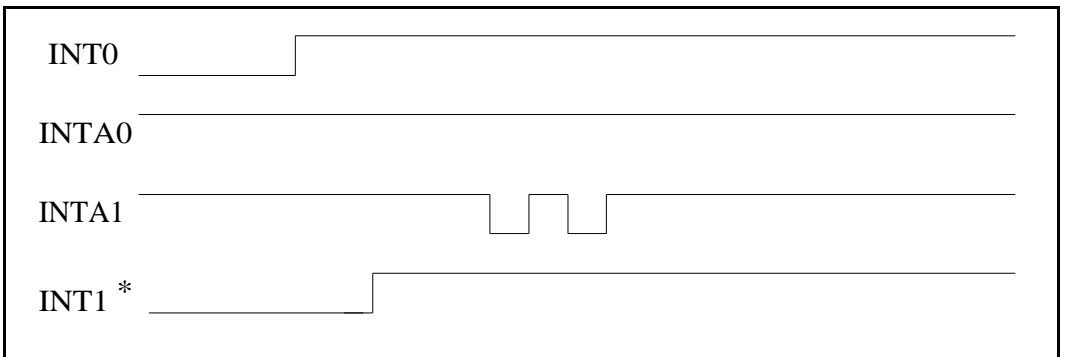
Figure 6. INT0 and INT1 Acknowledge Failure Due to the Higher Priority INT1

If INT0 and INT1 are configured in cascade mode and the higher priority INT1 occurs between INT0 and its expected acknowledge, then the acknowledge will appear on INTA1# instead of INTA0# (Figure 6).

*Note: This problem occurs only if INT1 is higher priority than INT0.
