# Intel® Celeron™ Processor Specification Update

Release Date: January 1999

Order Number: 243748-011

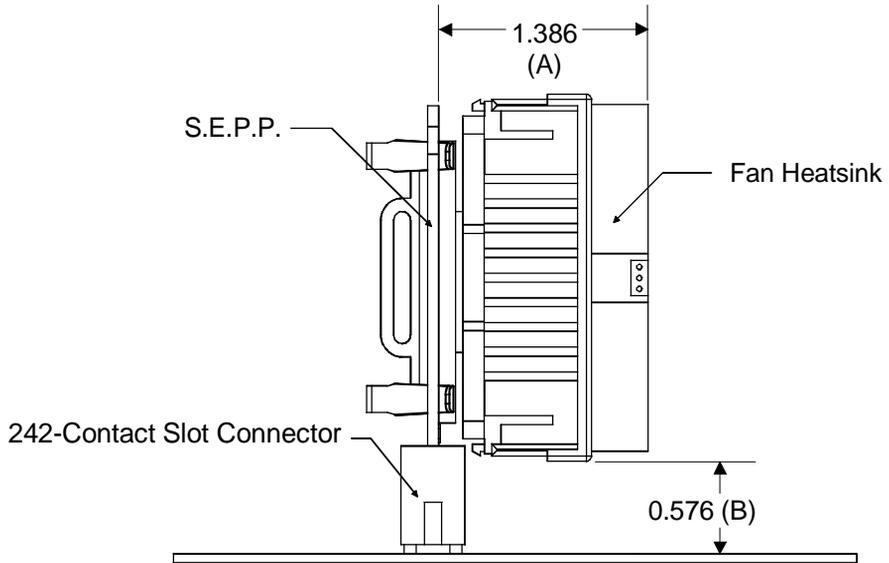
Figure 20. Side View Space Requirements for the Boxed Processor

Figures 20, 21, and 22, and Table 34 of Section 6.2 of the *Intel® Celeron™ Processor* datasheet show incorrect fan heat sink dimensions for the boxed Intel Celeron processor. The correct figures and table are shown below.

The maximum depth of the fan heat sink to the processor substrate should be 1.386", not 1.291" max. The minimum height clearance above the baseboard should be 0.576", not 0.485". The fan shroud height should be 2.02" and 4.74", respectively, not 2.19" max. and 4.90" max. Figure 22 should show reference "G" for the minimum airflow keepout zone from the inlet of the fan heat sink, and reference "F" for the minimum airflow keepout zone from the ends of the fan heat sink.
