Intel® Mobile Celeron™ Processor Specification Update

Release Date: 25 January 1999

Order Number: 244444-001

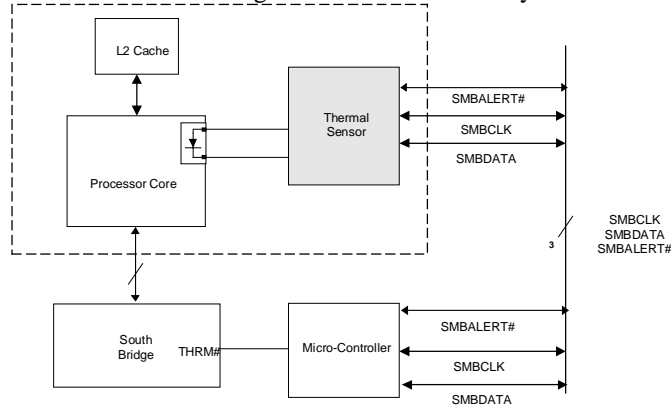
Figure 1. An Example of Microcontroller Driven Thermal Management

PROBLEM: The Intel® Mobile Celeron™ Processor Mobile Module has a thermal sensor that monitors the processor core's temperature. Please note that desktop systems could have a similar

thermal device. The thermal sensor asserts SMBALERT# if the processor temperature exceeds the temperature limits set in the Alarm Threshold Registers (T_{HIGH} , T_{LOW}). It also sets the corresponding Status Register bits to identify the cause of the interrupt. Figure 1 gives one example of the how the SMBALERT# signal could be used in a system.

Under the conditions described below, the thermal sensor incorrectly generates the SMBALERT# interrupt. *All* of the following conditions must be met to trigger a false interrupt:

1. Before servicing an interrupt from the thermal sensor, read and compare the processor thermal reading with the threshold limits (T_{HIGH} or T_{LOW}). Figures 2 and 3 provide basic flowcharts for the implementation of this workaround in an interrupt driven system.
2. If the firmware implemented polls the Status Register only, then before taking any action, re-read the temperature register and do a comparison with the alarm threshold limits (T_{HIGH} or T_{LOW}) to determine if the value is actually still within the temperature window.
