# Intel® Mobile Celeron™ Processor Specification Update

Release Date: April 1999

Order Number: 244444-003

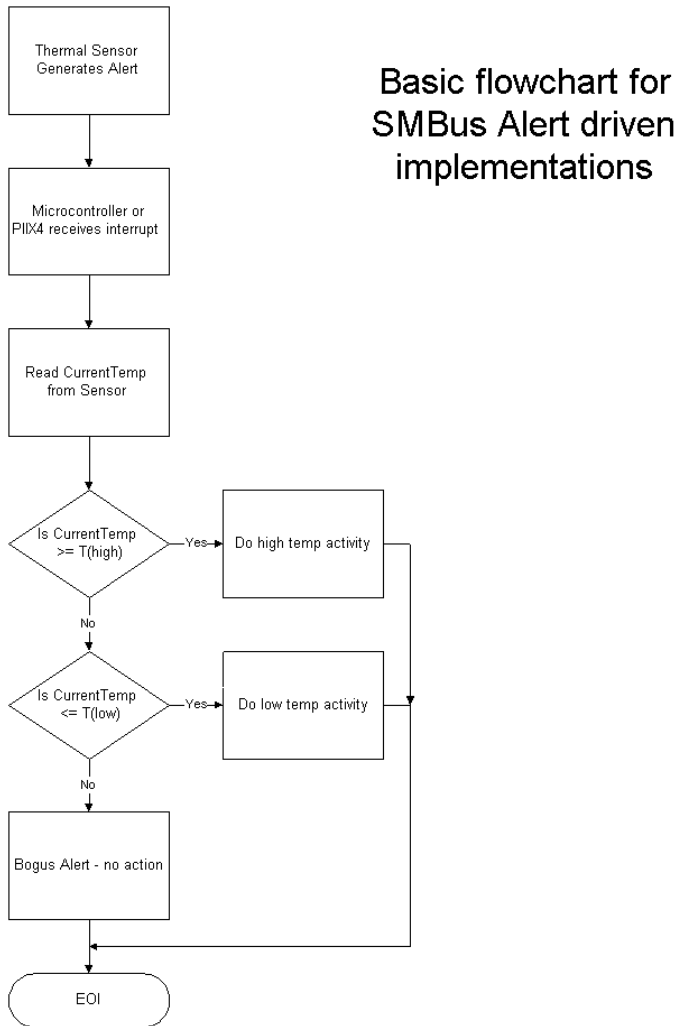
Figure 2. Workaround Flowchart: SMBALERT#-Driven System

## H29. Thermal Sensor May Assert SMBALERT# Incorrectly

Under the conditions described below, the thermal sensor incorrectly generates the SMBALERT# interrupt. *All* of the following conditions must be met to trigger a false interrupt:

**WORKAROUND:** Three different (mutually exclusive) workarounds are possible:

1. Before servicing an interrupt from the thermal sensor, read and compare the processor thermal reading with the threshold limits ( $T_{HIGH}$  or  $T_{LOW}$ ). Figures 2 and 3 provide basic flowcharts for the implementation of this workaround in an interrupt driven system.
2. If the firmware implemented polls the Status Register only, then before taking any action, re-read the temperature register and do a comparison with the alarm threshold limits ( $T_{HIGH}$  or  $T_{LOW}$ ) to determine if the value is actually still within the temperature window.
3. Use a temperature polling scheme to monitor the processor temperature.
