Mobile Intel[®] Celeron[®] Processor at 466 MHz, 433 MHz, 400 MHz, 366 MHz, 333 MHz, 300 MHz, and 266 MHz Specification Update

Release Date: November 2001

Order Number: 244444-028

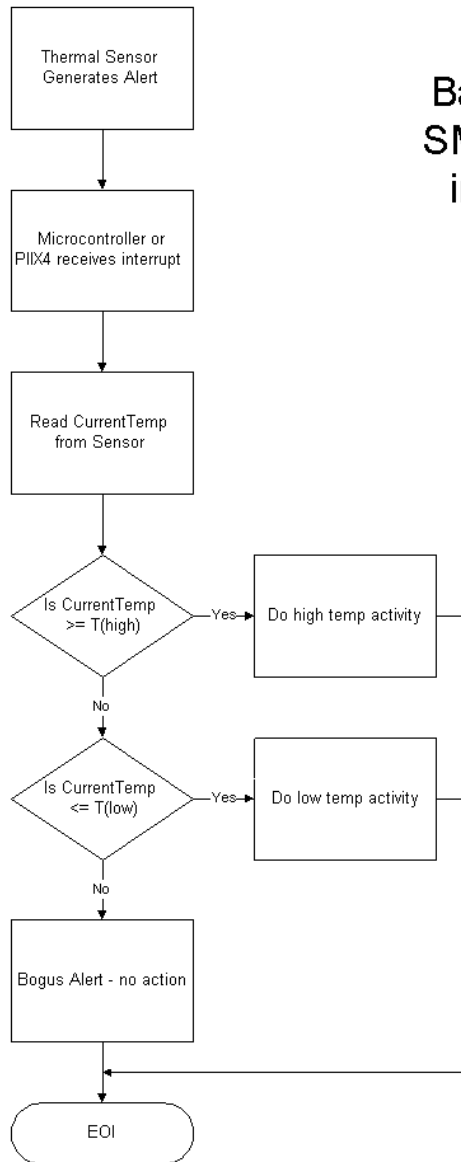
Figure 2. Workaround Flowchart: SMBALERT#-Driven System

H29. Thermal Sensor May Assert SMBALERT# Incorrectly

Problem: The Intel Celeron Processor Mobile Module has a thermal sensor that monitors the processor core's temperature. Please note that desktop systems could have a similar thermal device. The thermal sensor asserts SMBALERT# if the processor temperature exceeds the temperature limits set in the Alarm Threshold Registers (T_{HIGH} , T_{LOW}). It also sets the corresponding Status Register bits to identify the cause of the interrupt. Figure 1 gives one example of the how the SMBALERT# signal could be used in a system.

Implication: There is no system impact from this erratum if temperature polling is used for processor thermal management. If the SMBALERT# interrupt is employed to manage processor thermal sensing, then servicing the false interrupt may result in premature system action depending on the software and hardware implementations used. The rate of the false interrupts is less than the auto-convert rate of the thermal sensor.

1. Before servicing an interrupt from the thermal sensor, read and compare the processor thermal reading with the threshold limits (T_{HIGH} or T_{LOW}). Figures 2 and 3 provide basic flowcharts for the implementation of this workaround in an interrupt driven system.
2. If the firmware implemented polls the Status Register only, then before taking any action, re-read the temperature register and do a comparison with the alarm threshold limits (T_{HIGH} or T_{LOW}) to determine if the value is actually still within the temperature window.
3. Use a temperature polling scheme to monitor the processor temperature.
