Pentium® II Xeon™ Processor Specification Update

Release Date: January 1999

Order Number: 243776-009

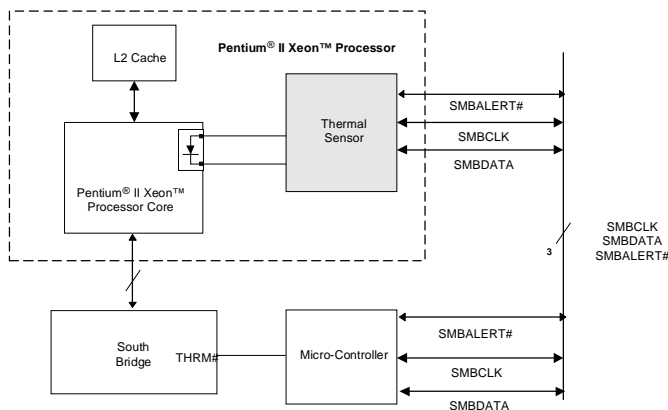
Figure 1. An Example of Microcontroller Driven Thermal Management

D30. Thermal Sensor May Assert SMBALERT# Incorrectly

PROBLEM: The Pentium II Xeon processor has a thermal sensor that monitors the processor core's temperature. The thermal sensor asserts SMBALERT# if the processor temperature exceeds the temperature limits set in the Alarm Threshold Registers (T_{HIGH} , T_{LOW}). It also sets the corresponding Status Register bits to identify the cause of the interrupt. Figure 1 gives one example of the how the SMBALERT# signal could be used in a system.

Under the conditions described below, the thermal sensor incorrectly generates the SMBALERT# interrupt. *All* of the following conditions must be met to trigger a false interrupt:

WORKAROUND: Three different (mutually exclusive) workarounds are possible:

1. Before servicing an interrupt from the thermal sensor, read and compare the processor thermal reading with the threshold limits (T_{HIGH} or T_{LOW}). Figures 2 and 3 provide basic flowcharts for the implementation of this workaround in an interrupt driven system.
2. If the firmware implemented polls the Status Register only, then before taking any action, re-read the temperature register and do a comparison with the alarm threshold limits (T_{HIGH} or T_{LOW}) to determine if the value is actually still within the temperature window.
3. Use a temperature polling scheme to monitor the processor temperature.
