Intel[®] Pentium[®] II Xeon[™] Processor Specification Update

Release Date: March 2001

Order Number: 243776-030

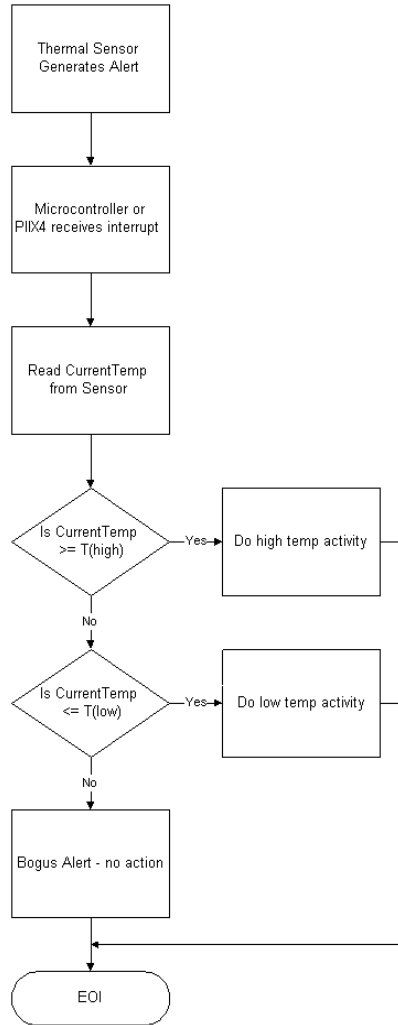
Figure 2. Workaround Flowchart: SMBALERT#-Driven System

D30. Thermal Sensor May Assert SMBALERT# Incorrectly

Under the conditions described below, the thermal sensor incorrectly generates the SMBALERT# interrupt. *All* of the following conditions must be met to trigger a false interrupt:

1. Before servicing an interrupt from the thermal sensor, read and compare the processor thermal reading with the threshold limits (T_{HIGH} or T_{LOW}). Figures 2 and 3 provide basic flowcharts for the implementation of this workaround in an interrupt driven system.
2. If the firmware implemented polls the Status Register only, then before taking any action, re-read the temperature register and do a comparison with the alarm threshold limits (T_{HIGH} or T_{LOW}) to determine if the value is actually still within the temperature window.
3. Use a temperature polling scheme to monitor the processor temperature
