Intel[®] Pentium[®] II Xeon[™] Processor Specification Update

Release Date: January 2002

Order Number: 243776-032

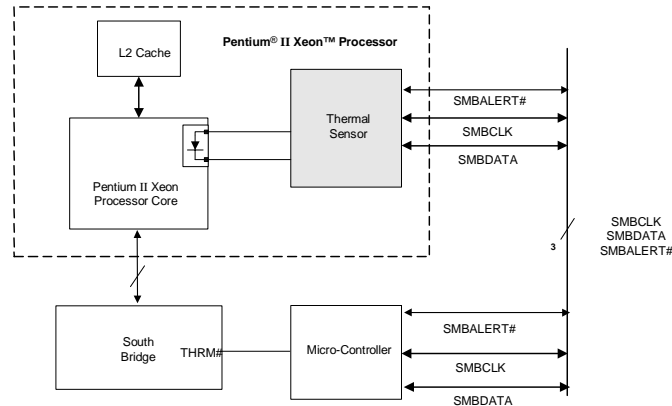
Figure 1. An Example of Microcontroller Driven Thermal Management

D30. Thermal Sensor May Assert SMBALERT# Incorrectly

Problem: The Pentium II Xeon processor has a thermal sensor that monitors the processor core's temperature. The thermal sensor asserts SMBALERT# if the processor temperature exceeds the temperature limits set in the Alarm Threshold Registers (T_{HIGH} , T_{LOW}). It also sets the corresponding Status Register bits to identify the cause of the interrupt. Figure 1 gives one example of the how the SMBALERT# signal could be used in a system.

Under the conditions described below, the thermal sensor incorrectly generates the SMBALERT# interrupt. *All* of the following conditions must be met to trigger a false interrupt:
