# **Pentium<sup>®</sup> II Processor Specification Update**

Release Date: July 1997

Order Number: 243337-003

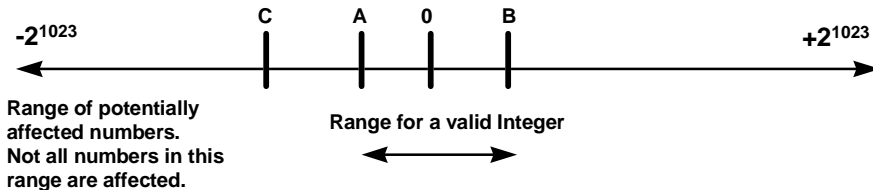
**IMPLICATION:** Erroneous operation results when the operand is so large that it will not fit into the target data size. The operands affected by this erratum are significantly outside (by a factor of 3X) the range that can be, correctly, converted to an integer value. The figure below and corresponding table identifies the normal range of integer numbers (between A and B) and the starting point of the operands affected by this erratum. Discrete failing operands will be present in the range between point C and the maximum negative number that can be represented by the processor ( $-2^{1023}$  in double precision format). Note 2 below gives a qualitative description of the nature of the discrete failing values. Software that does not rely on the Invalid Operation

exception flag being set and signaled by either an exception OR by software polling is not impacted by this erratum.

16-bit Operation	A	B	C
	-32,768.0	+32,767.0	< -98304.0
32-bit Operation	A	B	C
	-2,147,483,648.0	+2,147,483,647.0	< -6,442,450,944.0

**WORKAROUND:** Any of two software workarounds will avoid occurrence of this erratum:

1. Range checking performed prior to execution of the FIST[P] instruction will prevent the overflow condition from occurring, and may already be implemented as a standard coding style.
2. Software can use the presence of MAXNEG in the result integer to indicate that an out of range conversion may have occurred.
