# Pentium<sup>®</sup> II Processor Specification Update

Release Date: March 1999

Order Number: 243337-024

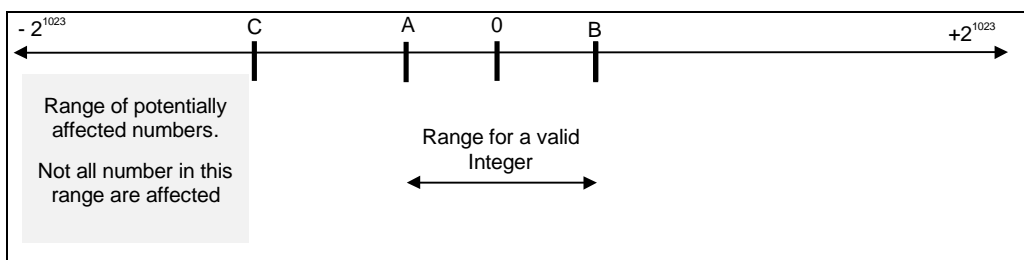
**IMPLICATION:** Erroneous operation results when the operand is so large that it will not fit into the target data size. The operands affected by this erratum are significantly outside (by a factor of 3X) the range that can be, correctly, converted to an integer value. The figure below and corresponding table identifies the normal range of integer numbers (between A and B) and the starting point of the operands affected by this erratum. Discrete failing operands will be present in the range between point C and the maximum negative number that can be represented by the processor ( $-2^{1023}$  in double precision format). Note 2 below gives a qualitative description of the nature of the discrete failing values. Software that does not rely on the Invalid Operation exception flag being set and signaled by either an exception OR by software polling is not impacted by this erratum.

16-bit Operation	A	B	C
	-32,768.0	+32,767.0	< -98304.0
32-bit Operation	A	B	C
	-2,147,483,648.0	+2,147,483,647.0	< -6,442,450,944.0

**WORKAROUND:** Any of two software workarounds will avoid occurrence of this erratum:

1. Range checking performed prior to execution of the FIST[P] instruction will prevent the overflow condition from occurring, and may already be implemented as a coding style.
2. Software can use the presence of MAXNEG in the result integer to indicate that an out of range conversion may have occurred.

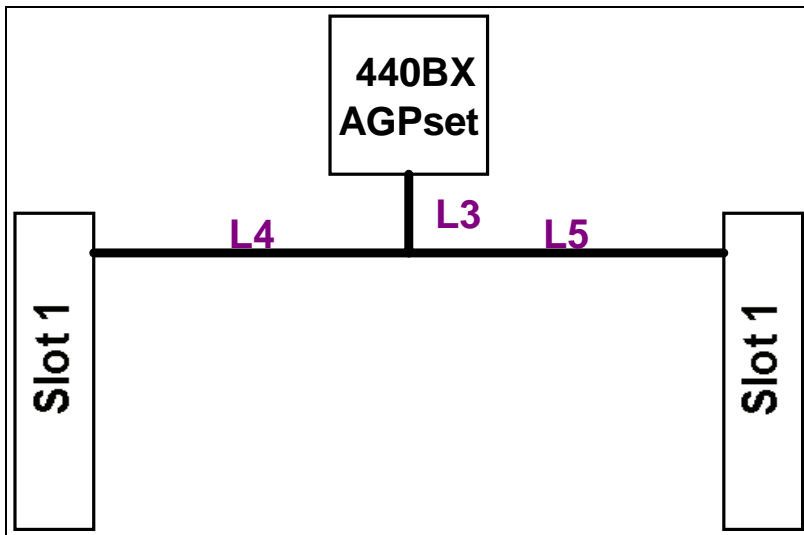
Figure 2. DP Dual Ended Termination (DET)

For DP topologies (see Figure 2) installed with a processor and a termination card,  $L4 + L3$  or  $L5 + L3$  must be less than or equal to 4.5". Additionally, for DP platforms with one processor installed, the termination card should be placed in the longer leg.

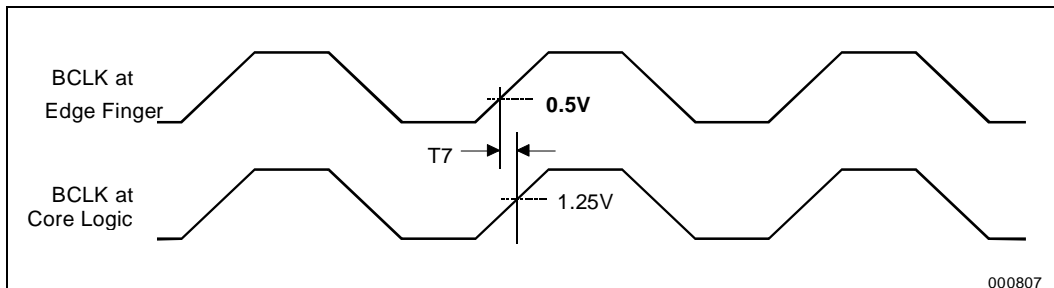
**Figure 6. BCLK to Core Logic Offset**

In Figure 6 of the *Pentium® II Processor at 233 MHz, 266 MHz, 300 MHz, and 333 MHz* datasheet, the following changes should be made:

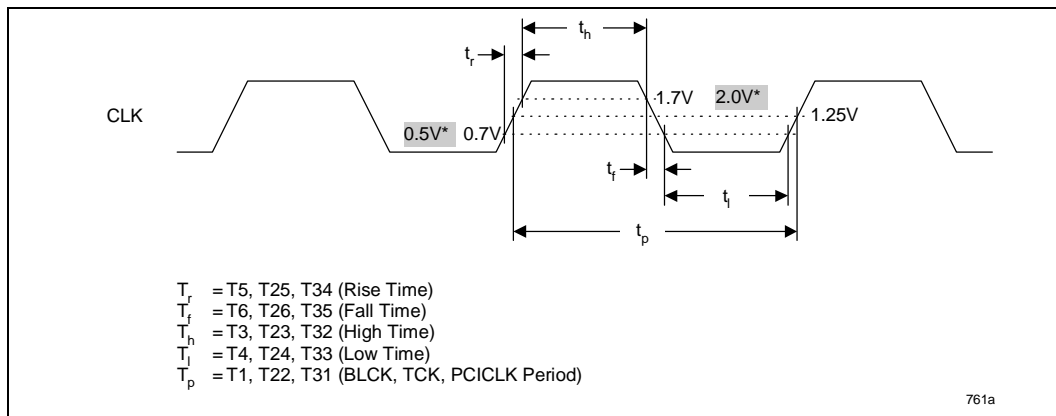
Figure 7. BCLK\*, PICCLK, and TCK Generic Clock Waveform

In Figure 7 of the *Pentium® II Processor at 233 MHz, 266 MHz, 300 MHz, and 333 MHz* datasheet, the following changes should be made:
