Pentium[®] II Processor Specification Update

Release Date: April 1999

Order Number: 243337-025

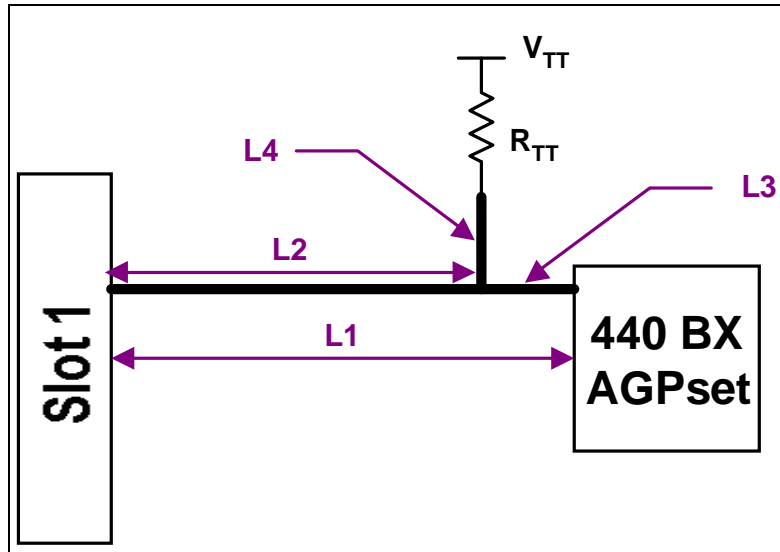
Figure 1. UP Dual Ended Termination (DET)

IMPLICATION: This violation of the bus exchange protocol when using a reduced arbitration latency may cause a system-level setup timing violation on the address, address parity, request command, or request parity signals on the system bus. This may result in a system hang or assertion of the AERR# signal, causing an attempted corrective action or shutdown of the system, as the system hardware and software dictate. The possibility of failure due to the contention caused by this erratum may be increased due to the processor's internal active pull-up of these signals on the clock after the signals are no longer being driven by the processor.

For UP-DET topologies (see Figure 1), the trace length $L1$ must be between 1.5" to 4.5" while using a 56 Ω termination resistor.
