Intel[®] Pentium[®] II Processor Specification Update

Release Date: August 2001

Order Number: 243337-043

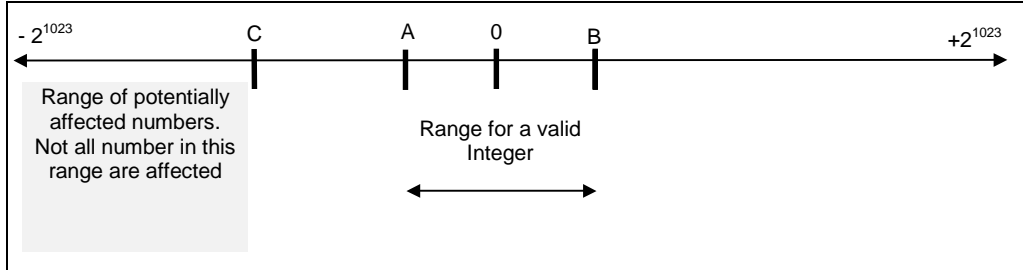
Problem: On certain, large, negative, floating-point operands, and only in three of the four possible processor rounding modes, the instructions FIST[P] m16int and FIST[P] m32int do not detect that the operand is so large that it will not fit into the target data size. As a consequence, the expected Invalid Operation exception response for this situation is not correctly provided, nor is the Invalid Operation flag set in the Floating-Point status word as specified in the *Intel Architecture Software Developer's Manual, Volume 2: Instruction Set Reference*. Under the failing conditions, noted below, the precision exception (#PE) flag will also be incorrectly set.

Implication: Erroneous operation results when the operand is so large that it will not fit into the target data size. The operands affected by this erratum are significantly outside (by a factor of 3X) the range that can be, correctly, converted to an integer value. The figure below and corresponding table identifies the normal range of integer numbers (between A and B) and the starting point of the operands affected by this erratum. Discrete failing operands will be present in the range between point C and the maximum negative number that can be represented by the processor (-2^{1023} in double precision format). Note 2 below gives a qualitative description of the nature of the discrete failing values. Software that does not rely on the Invalid Operation exception flag being set and signaled by either an exception OR by software polling is not impacted by this erratum.

16-bit Operation	A	B	C
	-32,768.0	+32,767.0	< -98304.0
32-bit Operation	A	B	C
	-2,147,483,648.0	+2,147,483,647.0	< -6,442,450,944.0

Workaround: Any of two software workarounds will avoid occurrence of this erratum:

1. Range checking performed prior to execution of the FIST[P] instruction will prevent the overflow condition from occurring, and may already be implemented as a coding style.
2. Software can use the presence of MAXNEG in the result integer to indicate that an out of range conversion may have occurred.
