# Mobile Pentium® II Processor Specification Update

Release Date: January 25, 1999

Order Number: 243887-007

The Mobile Pentium® II processor or the Intel® Pentium II Processor Mobile Module may contain design defects or errors known as errata which may cause the product to deviate from published specifications. Current characterized errata are documented in this Specification Update.

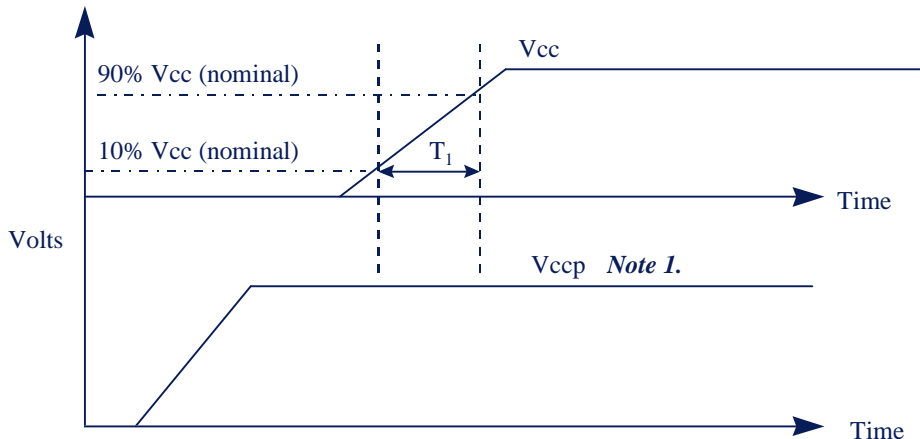
**Figure 1. V<sub>CC</sub>/V<sub>CCP</sub> Timing Requirements (Mobile)**

**PROBLEM:** The processor uses the PWRGOOD signal to ensure that no voltage sequencing issues arise; no pin assertions should cause the processor to change its behavior until this signal is asserted, when all power supplies and clocks to the processor are valid and stable. However, if  $V_{CC}$  ramps up before  $V_{CCP}$ , it will cause the processor to enter an invalid state.

**IMPLICATION:** If this erratum occurs, the system may boot normally however, the L2 cache may not be initialized.

**WORKAROUND:** For Mobile Pentium II processors, ensure that  $V_{CC}$  ramps after or with the L2 cache IO voltage ( $V_{CCP}$ ). If  $V_{CCP}$  ramps after the  $V_{CC}$ , a delay circuit can be placed on the core  $V_{CC}$  to ensure that  $V_{CC}$  ramps at the same time or after  $V_{CCP}$  as shown below in Figure 1.

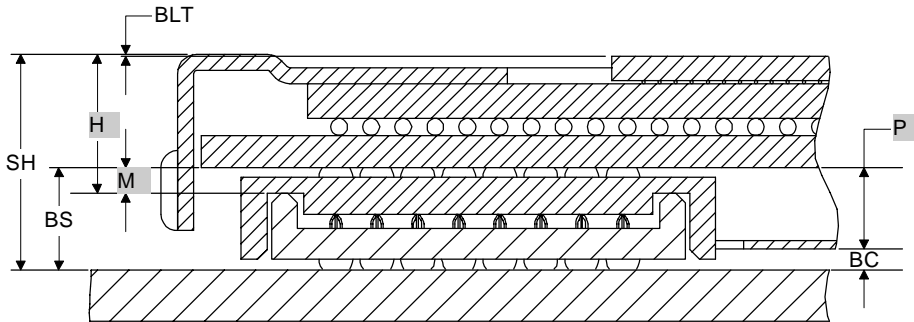
Figure 5.6. Cross Sectional View with Vertical Dimensions

**B12. Misabeled Vertical Dimension Parameters**

Figure 5.6 in the *Mobile Pentium® II Processor at 233 MHz, 266 MHz, and 300 MHz* datasheet should be replaced by the following figure:
