Mobile Intel[®] Pentium[®] II Processor Specification Update

Release Date: November 2001

Order Number: 243887-035

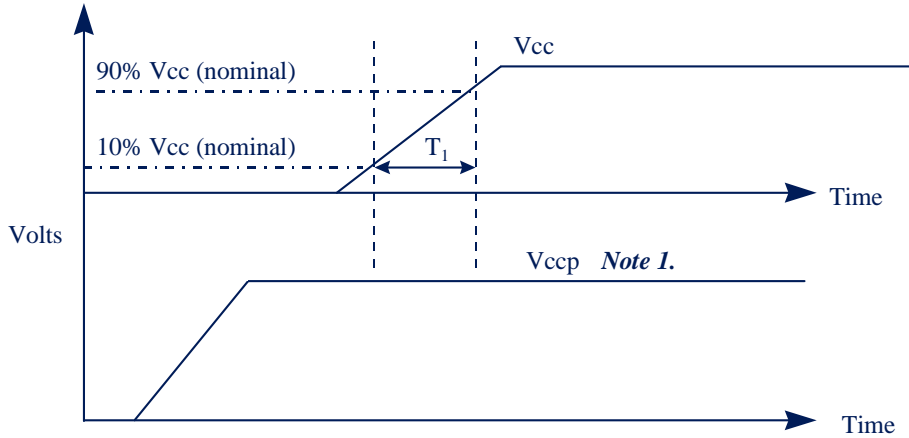
Figure 1. V_{CC}/V_{CCP} Timing Requirements (Mobile)

Problem: The processor uses the PWRGOOD signal to ensure that no voltage sequencing issues arise; no pin assertions should cause the processor to change its behavior until this signal is asserted, when all power supplies and clocks to the processor are valid and stable. However, if V_{CC} ramps up before V_{CCP} , it will cause the processor to enter an invalid state.

Implication: If this erratum occurs, the system may boot normally however, the L2 cache may not be initialized.

Workaround: For Mobile Pentium II processors, ensure that V_{CC} ramps after or with the L2 cache IO voltage (V_{CCP}). If V_{CCP} ramps after the V_{CC} , a delay circuit can be placed on the core V_{CC} to ensure that V_{CC} ramps at the same time or after V_{CCP} as shown below in Figure 1.

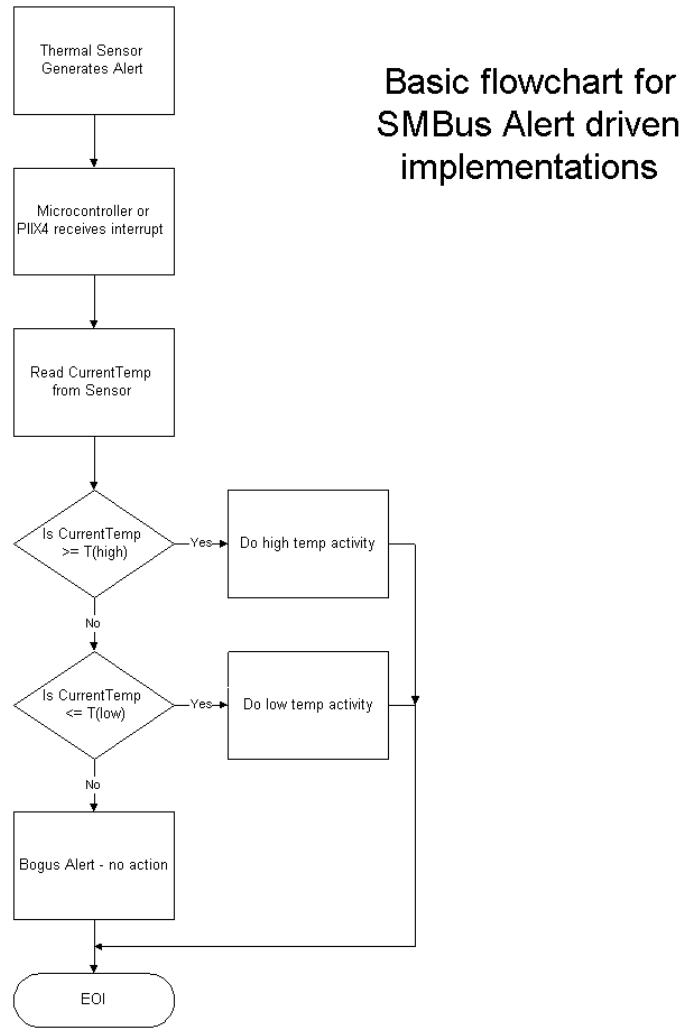
Figure 2. Workaround Flowchart: SMBALERT#-Driven System

Under the conditions described below, the thermal sensor incorrectly generates the SMBALERT# interrupt. *All* of the following conditions must be met to trigger a false interrupt:

1. Before servicing an interrupt from the thermal sensor, read and compare the processor thermal reading with the threshold limits (T_{HIGH} or T_{LOW}). Figures 2 and 3 provide basic flowcharts for the implementation of this workaround in an interrupt driven system.
2. If the firmware implemented polls the Status Register only, then before taking any action, re-read the temperature register and do a comparison with the alarm threshold limits (T_{HIGH} or T_{LOW}) to determine if the value is actually still within the temperature window.
