Intel[®] Pentium[®] III Processor Specification Update

Release Date: August 2007

Document Number: 244453-058

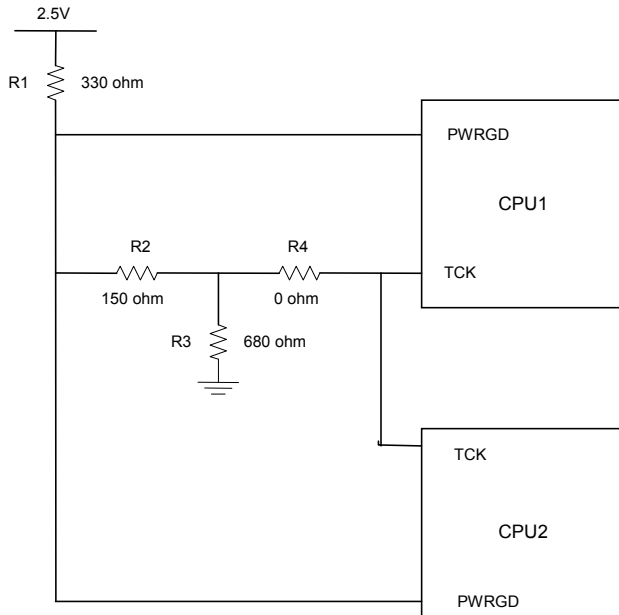
Pentium® III Processor with 512KB L2 Cache Platforms Workaround

In addition, the example workaround circuits shown do not support production baseboard test methodologies that require the use of the processor JTAG/TAP port. Alternative workaround solutions must be found if such test capability is required.

Assumes the inputs to the CPU_PWRGD are open collector signals that are Wire-ANDed together

- The example workaround circuit assumes that the PWRGD inputs into the processors are open collector. Tying the PWRGD inputs together in a Wired-AND fashion allows each processor to receive PWRGD at the same time but at the latter of the 2 separate PWRGD assertions. If separation of the PWRGD inputs to each processor is required, extra circuitry will be required.
