Pentium[®] Processor for Embedded Applications

Specification Update

December 1998

Order Number: 273183-002

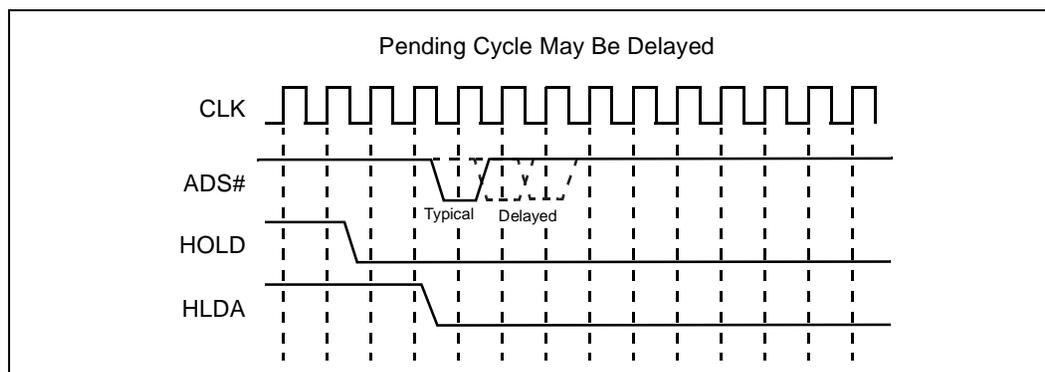
Problem: The Pentium processor typically starts a pending bus cycle on the same clock that HLDA is deasserted and the Pentium processor with MMX technology typically starts the cycle one clock after HLDA is deasserted. However, in both processors it may be delayed by as many as two clocks. See the diagram below:

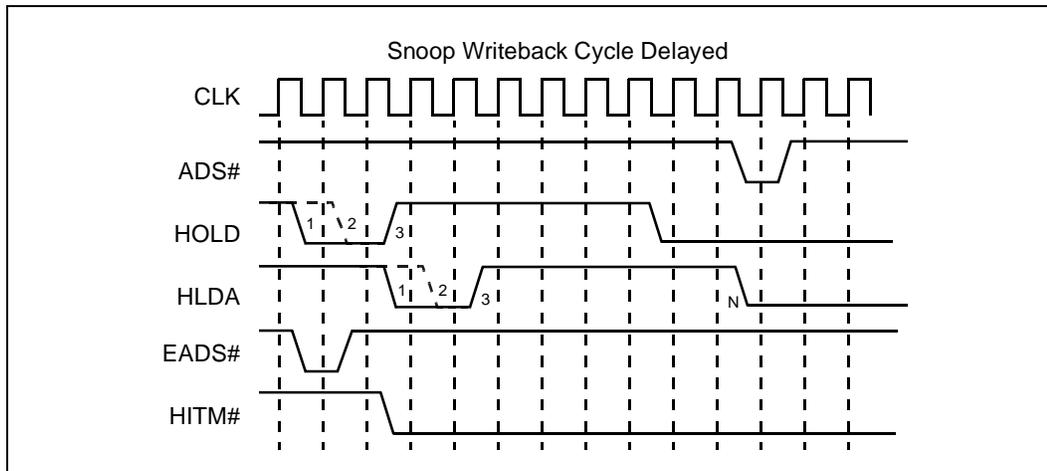
In two cases, for example, if HOLD is deasserted for one clock (i.e., clock 2) or two clocks (i.e., clocks 1 & 2) and then reasserted, the window may not be large enough to start a pending snoop writeback cycle. The writeback cycle may be delayed until the HLDA is deasserted again (i.e., clock N). See diagram below.

Implication: If the system expects a cycle, for example a writeback cycle, and depends on this cycle to commence within the HLDA deassertion window, then the system may not complete the handshake and cause a hang.

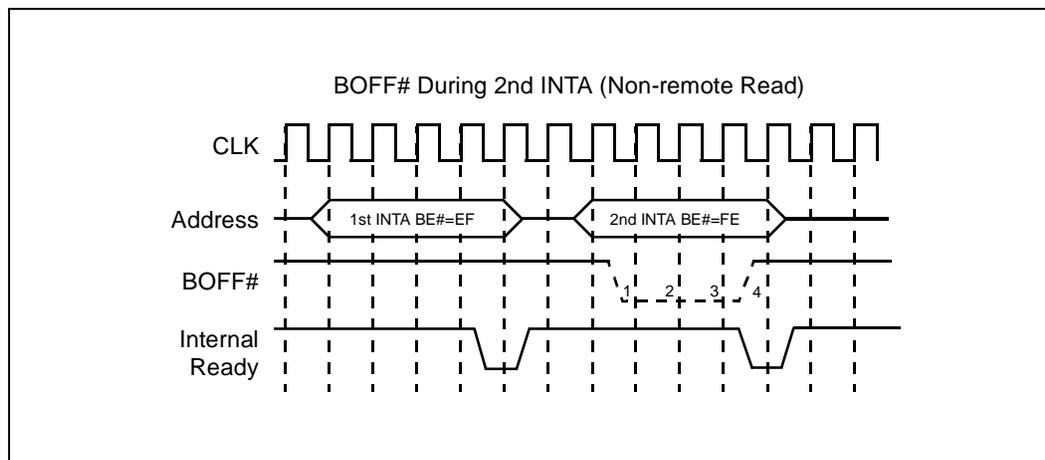
If these conditions occur while a remote read message is being sent or received, the second INTA cycle may take up to 8 clocks to complete (counting from clock 1). BOFF# is not latched and must remain asserted until after the 2nd INTA completes (e.g., for 8 clocks).

Similarly, if HOLD is asserted anytime during the second INTA cycle, and during a remote read, the processor will hang.

Implication: If the system does not assert BOFF# when the processor bus is idle, then this problem will not occur. Internal APIC INTA cycles are run only when the bus is idle, thus asserting BOFF# during an external bus cycle (e.g., started by an ADS#) will avoid these circumstances. In systems that can assert BOFF# when the bus is idle, asserting BOFF# for a least 4 clocks will avoid the problem for non-remote read cases. Note that there may be other implementations that guarantee BOFF# is not asserted in the problematic window. For example, if BOFF# is only asserted with AHOLD active and AHOLD always precedes BOFF# by at least 4 clocks, the erratum is avoided.
