## PRODUCT ALERT

# RGB561 220 MHz and 250 MHz, Blanking Skew

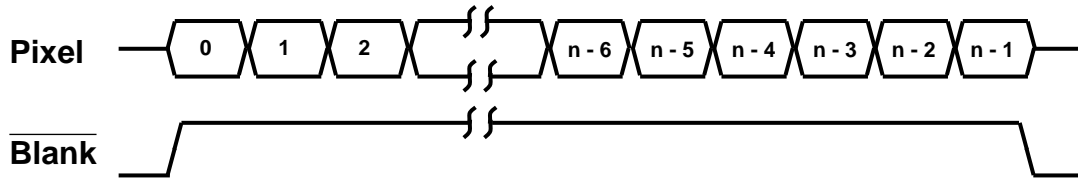
Fig 1a. Normal frame buffer, normal timing.

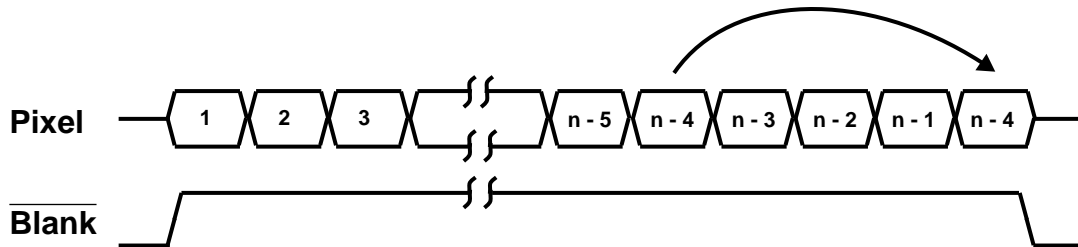
At high speeds the internal synchronization of the pixel data and the blank timing can become offset by one pixel clock, such that  $\overline{\text{CBLANKIN}}$  is “skewed to the right” by one pixel time relative to the pixel data. This causes two visible effects:

1. The first (left-most) pixel of each scan line is discarded.
2. An extra (right-most) pixel is displayed at the end of each scan line.

Each LOAD\_CLK clocks in a number of pixels which are multiplexed down at pixel clock speeds. The extra pixel that is displayed at the end of the scan line is left over from the previous LOAD\_CLK. If, for example, 4:1 multiplexing is used, whatever pixel is normally fourth from the end of the scan line is the pixel that will be incorrectly duplicated at the end of the scan line.

Fig 1b. Normal frame buffer, with timing problem. The left-most pixel is discarded and an extra pixel displays at the right.

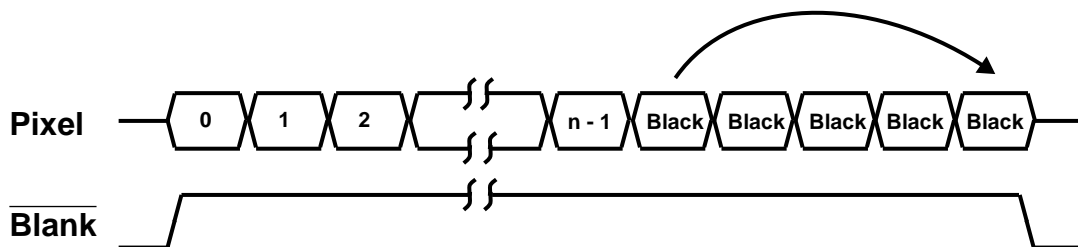
Fig 1d. Frame buffer with black pixels, with bad timing. The left-most black pixel is discarded; an extra black pixel displays at the right.

1. Start each line with one or more black pixels.
2. Adjust the timing of  $\overline{\text{CBLANKIN}}$  such that the black pixel is normally displayed. If the timing problem exists the black pixel will be discarded. If the timing problem does not exist the pixel will be displayed but will not be visible because it is black.
3. End each line with a string of black pixels. The number of black pixels to use is the number of pixels loaded with each LOAD\_CLK. E.g., in 4:1 mode use four black pixels.
4. Adjust the timing of  $\overline{\text{CBLANKIN}}$  such that the black pixels are normally displayed. If the timing problem

does not exist the black pixels will be displayed but will not be visible because they are black. If the timing problem exists an additional black pixel will be displayed.
