# **Intel 82374/5 EB/SB EISA Bridge PCIset Specification Update**

Release Date: April, 1997

Order Number 297735-002

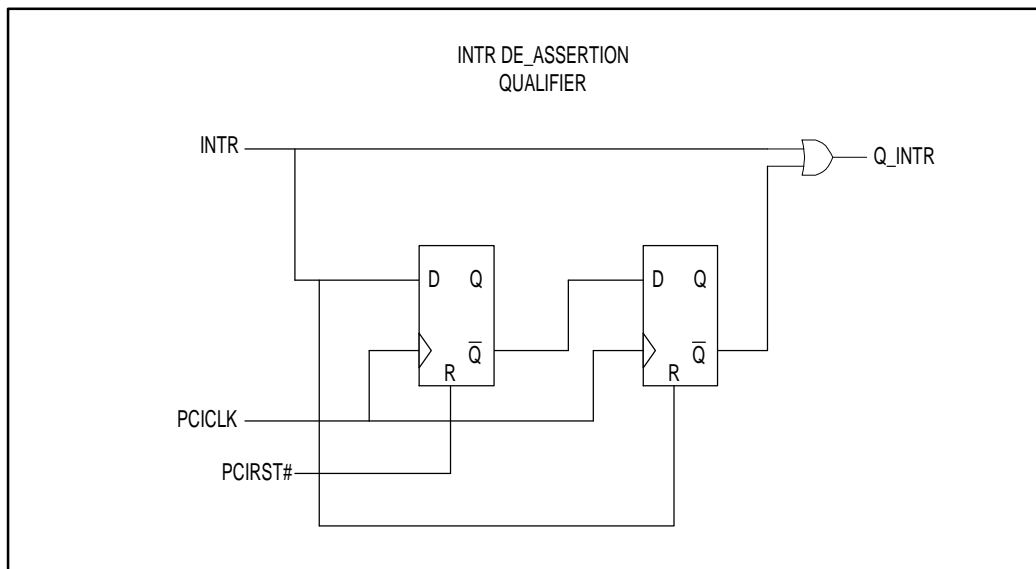
**PROBLEM:** While the ESC is driving INTR to the processor, and PEREQ# is asserted followed by either NMFLUSH# or EISAHLDA going low (for example when ownership of the EISA bus is given to the PCEB, or during interrupt acknowledge cycles), INTR will be de-asserted for one PCI clock.

**IMPLICATION:** Possible de-assertion of INTR for one PCI clock. This may generate spurious interrupts and can be potentially reported as "lost interrupts" under certain operating systems such as Novell.

**WORKAROUND:** A workaround has been provided which will allow de-assertion of INTR only if INTR is low for at least two PCI clocks.

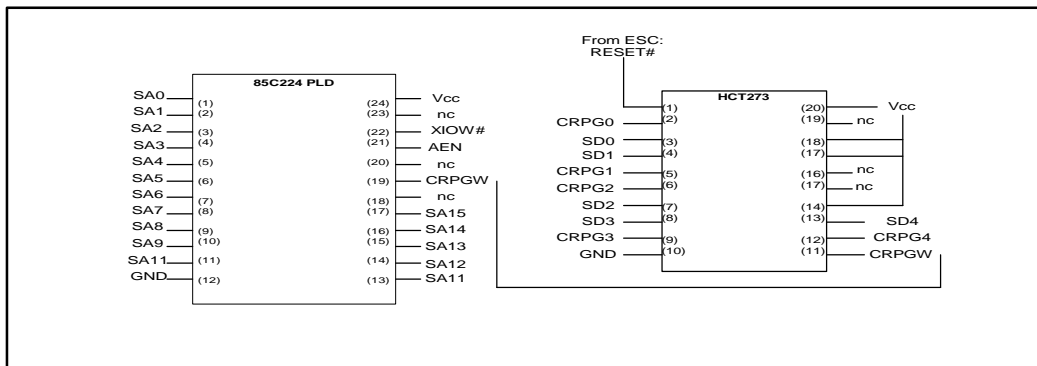
Figure 2: PLD Workaround #1

**PROBLEM:** EISA configuration RAM data. The 82374EB may not generate the proper page address on the LA[31:27]# lines during configuration RAM accesses under the following conditions: A DMA cycle or ISA refresh cycle, followed by another pending DMA, followed by an access to EISA configuration RAM (an EISA master should create the same problem).

**IMPLICATION:** During the configuration RAM reads, the 82374EB decodes the cycle properly and generates the signals necessary for the access. The system tries to access page xxxxx and program the proper page address into the C00h register. The 82374EB should drive xxxxx on LA[31:27]# at this time, but instead these address lines may float under the failing scenario. These address lines float when NMFLUSH# (New Master Flush) is asserted. NMFLUSH# gets asserted because of the back to back masters (EISA/ISA/refresh) being serviced.

1. The 85C224 PLD in fig. 2 is programmed to generate an IO write to I/O port 0C00h, which the ESC integrates as a configuration RAM page register. Upon seeing 0C00h on the address bus (SA[15:0]), AEN

asserted high for EISA bus master cycles, and an XIOW# asserted low, the PLD will drive its only output, CRPGW asserted high, as the clock signal input for the HCT273.

The reason for the driving the output high is that the HCT273 needs to see a rising edge on this clock signal in order to latch the correct CRAM page address. The HCT273 is an Octal D-type flip flop which is enabled on the rising edge of its clock signal input. The HCT273 will latch the correct CRAM page address off the data bus (SD[4:0]) and drive the address on its output signals (CRPG[4:0]). CRPG[4:0] are the synthesized versions of LA[31:27] and are tied to the corresponding inputs on the NVRAM. This solution is transparent to the system BIOS.

The actual pin assignments are given in fig. 2 above. This also includes the asserted values of the inputs and outputs (/ = symbol for asserted low). The following is the PLD equation (written in PLDshell Plus) for the data setup of the correct CRAM page address:

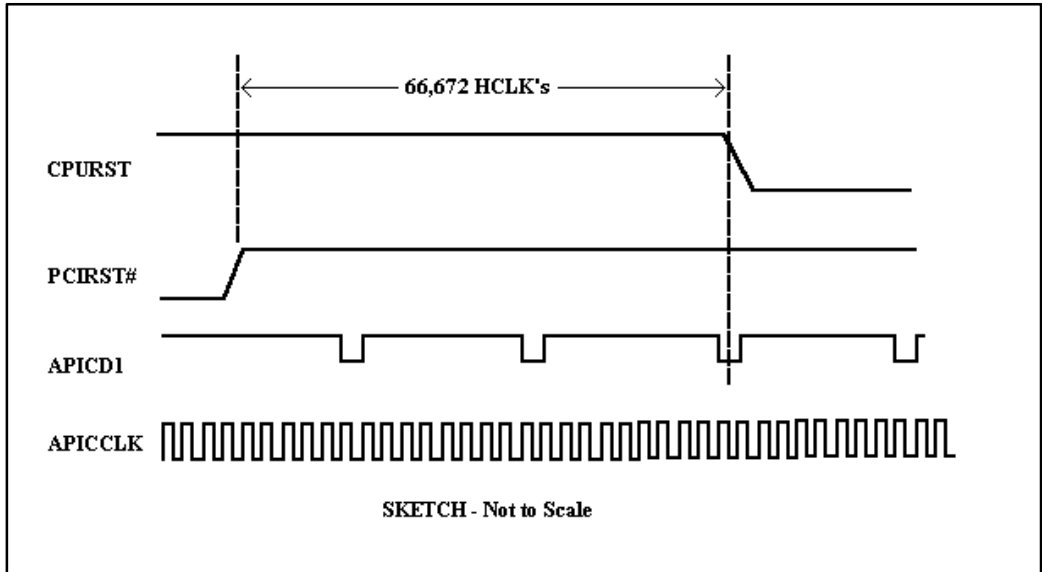
From the time that PCIRST# deasserts until the time that CPURST deasserts, the I/O APIC periodically pulses APICD1 low for one out of every 20 APICCLK's. If the pulse on APICD1 (APICEN) aligns with the falling edge of CPU RESET (CPURST), the local APIC's will not be enabled; this prevents proper DP or DP-ready functionality. See the figure below.

**Workaround #1:** Calculate the window for the APICD1 pulse relative to CPURST for a given host clock (HCLK) and APIC Clock (APICCLK) frequency. The following example demonstrates that by using a 60.0 MHz HCLK and a 16.0 MHz APICCLK (0.01% accuracy for both) the APICD1 pulse will be outside the sampling window of CPURST. With these equations, equally acceptable windows can be found for other values of HCLK and APICCLK.

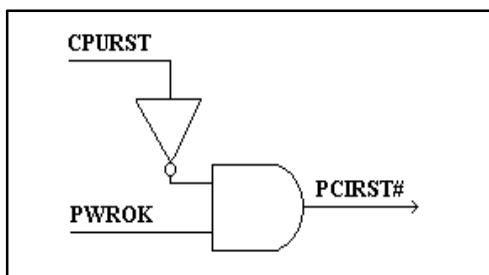
**Workaround “B”**

**NOTE:** Due to the combinational logic in workaround "b", there is a short time period (potentially several HCLKs) between the assertion of PWROK and the assertion of CPURST when PCIRST# actually deasserts. This deassertion of PCIRST# does not cause any system problems since it takes at least several hundred nanoseconds before any signals in the ESC will respond.

b) Connect a buffered version of CPURST to an inverter and then connect the output of this inverter to one input of a two-input AND gate. PWROK is the second input to the AND gate. The output of the AND gate becomes PCIRST# for the entire system. Again, the PCMC PCIRST# output pin (pin 147) should be disconnected from the system.

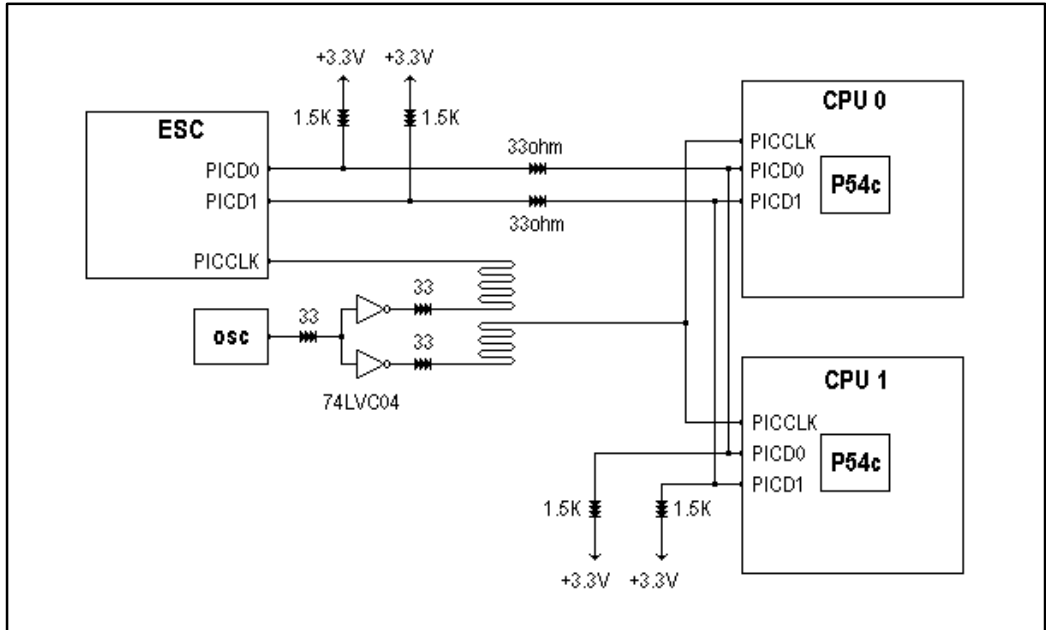
In addition to the signal quality susceptibility on the APICCLK input on the Pentium processor, there exists a similar issue with signal quality susceptibility on the Pentium processor's PICD0 and PICD1 data lines. In prior board layout designs, the APIC data lines were tied high to VCC3 with single 150 - 250 ohm pull-up resistors located near the Pentium processors. This has been re-designed.

The new design layout implements a termination scheme on the APIC data lines where two pull-up resistors, each located on opposite ends of the trace and in parallel, are implemented to maximize signal noise margin with minimal rise time (setup) penalty on these open drain signals.

The following are general guidelines & recommendations for the APIC Bus Layout Scheme:

- GENERAL:** Minimize the trace length between CPUs (mount as close together as possible).  
For maximum noise immunity (from cross coupling), separate APIC Bus signals from other signals on the board (esp. data bus) with at least 20 mil spacing.  
Keep the resistor terminators as close to the end of the lines as possible (as close to the components as possible).

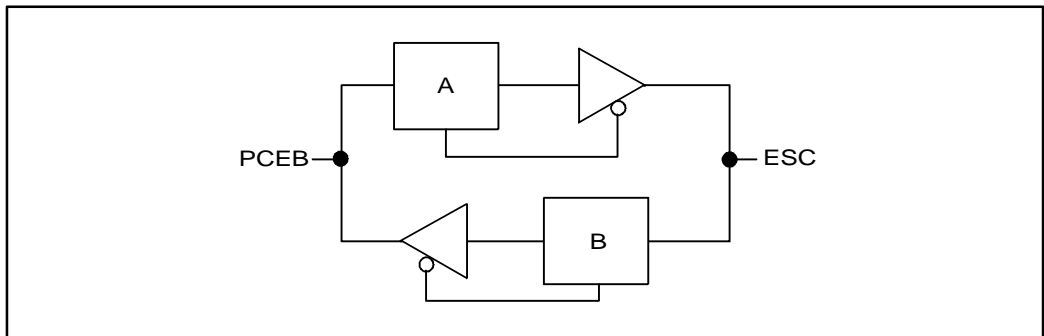
AFLUSH# PLD Workaround: Inserted Between PCEB and ESC AFLUSH# Signal

**PROBLEM:** In DP mode and during EISA/ISA/DMA transfers to PCI, an internal AC timing in the PCEB line buffers is violated, resulting in incorrect data driven onto the PCI bus. The failing scenario occurs during an APIC interrupt while the line buffers are flushing data and at the same time filling data. During that time, there is a window where the line buffer pointers do not change correctly.

The second workaround is designed to intercept the AFLUSH# signal between the PCEB and ESC (see figure below) in order to temporarily inhibit the assertion of the AFLUSH# signal to the PCEB. The AFLUSH# signal is held negated if there is an EISA-to-PCI transaction taking place. Once EISAHLDA is negated, the workaround will initiate the AFLUSH# protocol between the ESC and PCEB which will allow the APIC interrupt message to be sent to the processors. The workaround employs two state machines (using the PCI clock) that emulate the AFLUSH# logic from the both the PCEB and ESC perspectives.
