**Intel 450KX/GX PCIset
Specification Update
82454KX/GX (PB)
82453KX/GX (MC)
82452KX/GX (DP)
82451KX/GX (MIC)**

Release Date: October 1997

Order Number: 243109-012

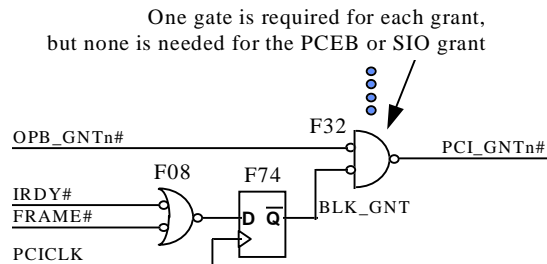
PROBLEM: During an inbound posted write burst, the 82454 PB may use the same data buffer for two adjacent transactions. This causes the first write to use and deallocate the data from the second write, corrupting data

IMPLICATION: Enabling inbound write posting may cause data corruption followed by a system hang. Disabling inbound write posting may result in significant I/O performance loss.

This arbiter must not perform overlapped arbitration. One way to ensure this is to implement the circuit described below, external to the arbiter. The actual workaround involves waiting for a bus idle before allowing a new grant to be issued. The IOQ depth must still be set to 1, and 2:1 interleaving must be used, to work around other errata which may surface when inbound write posting is enabled (even with this workaround). Note that this latter restriction requires at least 4 SIMM DRAM modules to be loaded at all times.

This following circuit is an implementation of the described workaround:

This workaround will allow inbound write posting to be enabled on A2 450KX PCIsset silicon, and will not affect the functionality of B0 450KX/GX PCIsset silicon, though a slight performance loss may result if this workaround is used with the B0 stepping. Enabling inbound posting by using this workaround is a significant performance enhancement for systems with A2 450KX PCIsset silicon; refer to Intel's World Wide Web site for more details on the performance loss incurred by disabling inbound write posting (at URL <http://www.intel.com/procs/support/ppro/82450.htm>).

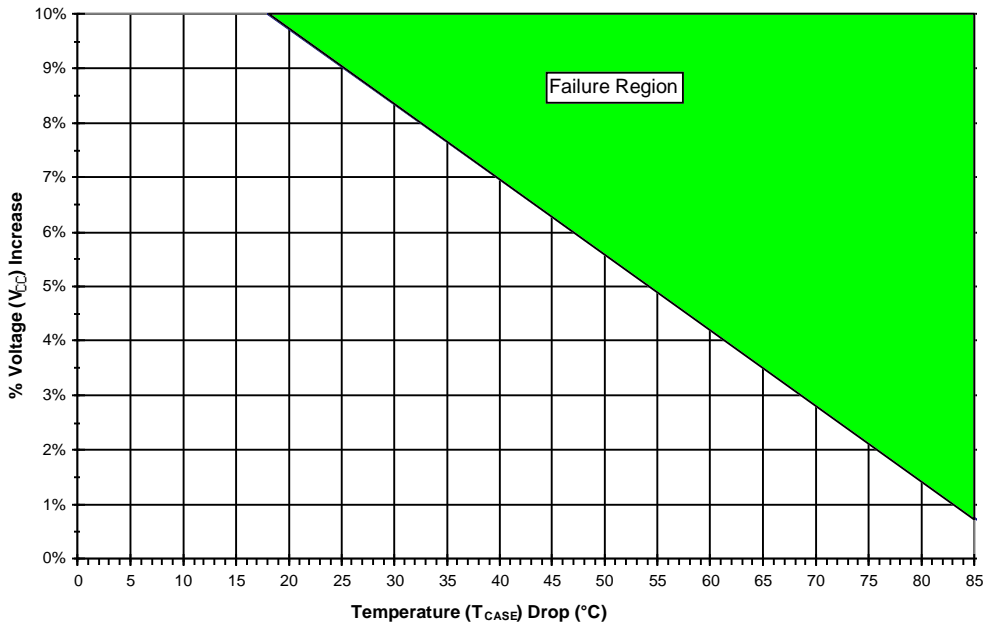
Figure 1. V_{CC} Increase vs. T_{CASE} Drop for DPLL Failure (Worst Case)

PROBLEM: Analysis of the DPLL (Digital Phase Lock Loop) units of the Intel 450KX PCIsset components has shown that a DPLL failure can occur during certain changes in temperature and/or voltage within the Intel 450KX PCIsset component specification, resulting in a loss of DPLL functionality for between 2 and 500 bus clocks.

After a device has undergone a hard reset of the DPLL (via the PLLRST pin), a drop in T_{CASE} accompanied by an increase in V_{CC} may cause this erratum to occur. The magnitude of the temperature drop and supply voltage increase required to cause this failure is graphed below:

IMPLICATION: If the T_{CASE} of any Intel 450KX PCIsset component is allowed to decrease by more than 18°C after the point at which DPLL lock is obtained after a DPLL hard reset, a positive voltage swing may cause the component to lose its internal clock for 2 - 500 processor bus clocks. This may result in a system hang, lost data, or other unpredictable system failure (note that if the component is not processing commands or data for the time during which the internal clock is lost, no failure will be observed). The larger the temperature drop and/or voltage swing, the more likely the failure.

If V_{CC} swings from 3.3V -5% to 3.3V +5%, and T_{CASE} does drop more than 18°C past the temperature at which the DPLL was reset, this erratum may occur. Similarly, if T_{CASE} transitions from 85°C (at DPLL reset time) to 0°C, a swing in V_{CC} of more than 0.5% may cause this erratum. Thus, maintaining a moderately constant T_{CASE} and V_{CC} will prevent this erratum, as per the graph above.

WORKAROUND: Ensure that the DPLL reset occurs during a period where the T_{CASE} is low and/or the V_{CC} is high relative to normal operational conditions (e.g., if the system is running at a high temperature and is powered down, allow it to cool before powering up again). Alternately, ensure that the system meets a restricted specification for changes in T_{CASE} and V_{CC} .

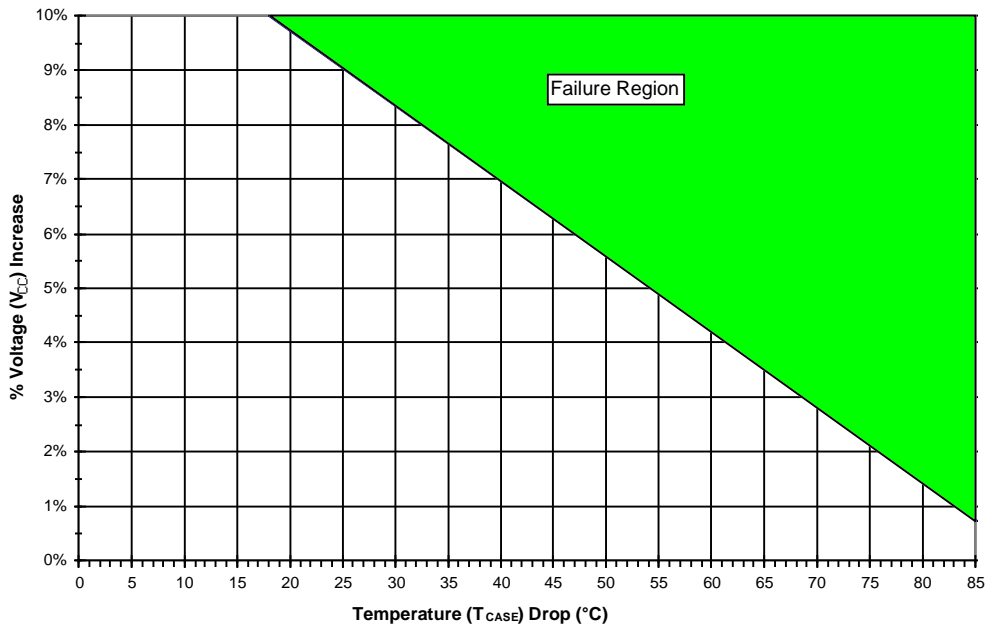
Figure 1. V_{CC} Increase vs. T_{CASE} Drop for DPLL Failure (Worst Case)

The current specification states that the Intel 450GX PCIsset is operational over a T_{CASE} range of 0 - 85°C and a V_{CC} range of 3.3V ± 5%.

After a device has undergone a hard reset of the DPLL (via the PLLRST pin), a drop in T_{CASE} accompanied by an increase in V_{CC} may cause this erratum to occur. The magnitude of the temperature drop and supply voltage increase required to cause this failure is graphed below:

IMPLICATION: If the T_{CASE} of any Intel 450GX PCIsset component is allowed to decrease by more than 18°C after the point at which DPLL lock is obtained after a DPLL hard reset, a positive voltage swing may cause the component to lose its internal clock for 2 - 500 processor bus clocks. This may result in a system hang, lost data, or other unpredictable system failure (note that if the component is not processing commands or data for the time during which the internal clock is lost, no failure will be observed). The larger the temperature drop and/or voltage swing, the more likely the failure.
