80C186XL/80C188XL EMBEDDED MICROPROCESSORS SPECIFICATION UPDATE

Release Date: June, 1997
Order Number: 272895.002

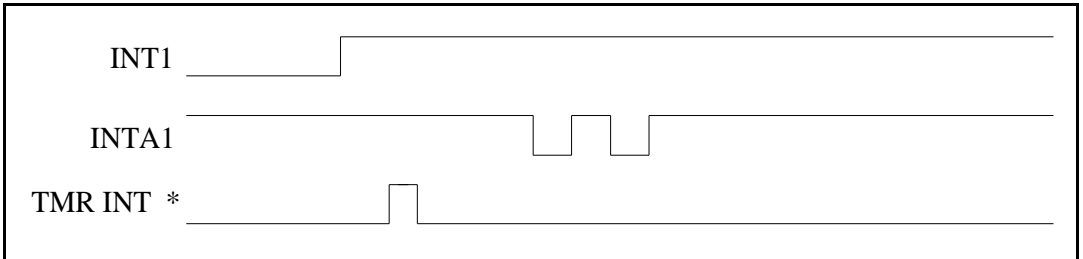
Figure 1. Correct INT1 Acknowledge Sequence with Higher Priority Timer Interrupt

Correct operation of the device acknowledges the interrupt on INTA1# after an interrupt on INT1. Normally, this occurs even if there is a higher priority interrupt after INT1 but before the acknowledge (Figure 1).

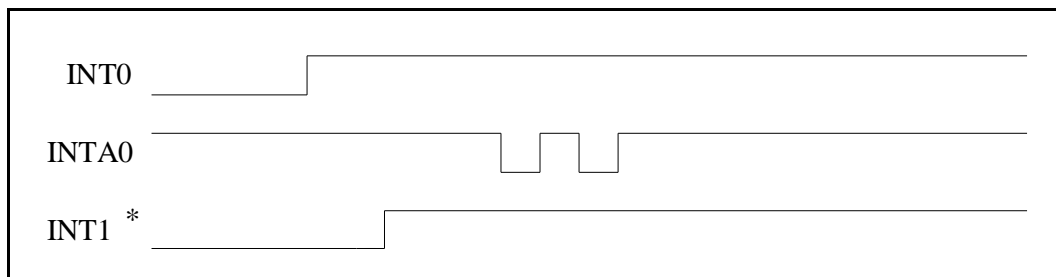
Figure 4. Correct INT0 Acknowledge Operation with a Simultaneous INT1

Correct operation acknowledges INT0 on INTA0#. Normally, this occurs even if there is a higher priority INT1 after INT0 but before the acknowledge (Figure 4).

*Note: INT1 is the only interrupt that causes the errata to occur.
