# Intel® Mobile Celeron™ Processor Specification Update

Release Date: April 1999

Order Number: 244444-003

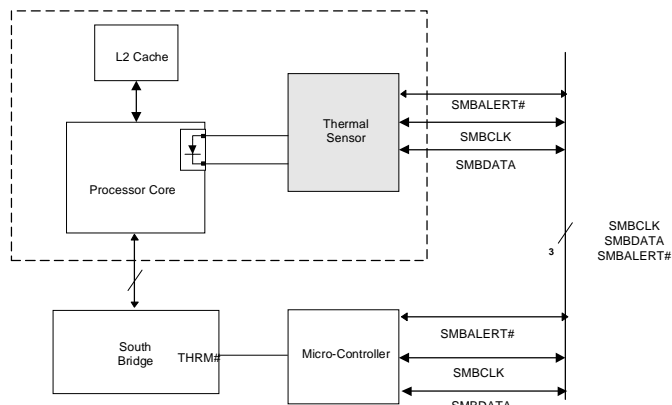
Figure 1. An Example of Microcontroller Driven Thermal Management

**PROBLEM:** The Intel Celeron Processor Mobile Module has a thermal sensor that monitors the processor core's temperature. Please note that desktop systems could have a similar thermal device. The thermal sensor asserts SMBALERT# if the processor temperature exceeds the temperature limits set in the Alarm Threshold Registers ( $T_{HIGH}$ ,  $T_{LOW}$ ). It also sets the corresponding Status Register bits to identify the cause of the interrupt. Figure 1 gives one example of the how the SMBALERT# signal could be used in a system.

Under the conditions described below, the thermal sensor incorrectly generates the SMBALERT# interrupt. *All* of the following conditions must be met to trigger a false interrupt:
