Mobile Intel[®] Celeron[®] Processor at 466 MHz, 433 MHz, 400 MHz, 366 MHz, 333 MHz, 300 MHz, and 266 MHz Specification Update

Release Date: November 2001

Order Number: 244444-028

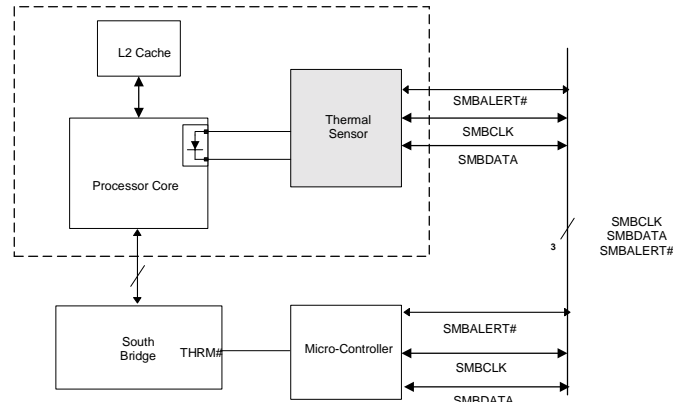
Figure 1. An Example of Microcontroller Driven Thermal Management

H29. Thermal Sensor May Assert SMBALERT# Incorrectly

Problem: The Intel Celeron Processor Mobile Module has a thermal sensor that monitors the processor core's temperature. Please note that desktop systems could have a similar thermal device. The thermal sensor asserts SMBALERT# if the processor temperature exceeds the temperature limits set in the Alarm Threshold Registers (T_{HIGH} , T_{LOW}). It also sets the corresponding Status Register bits to identify the cause of the interrupt. Figure 1 gives one example of the how the SMBALERT# signal could be used in a system.

Implication: There is no system impact from this erratum if temperature polling is used for processor thermal management. If the SMBALERT# interrupt is employed to manage processor thermal sensing, then servicing the false interrupt may result in premature system action depending on the software and hardware implementations used. The rate of the false interrupts is less than the auto-convert rate of the thermal sensor.
