Intel[®] Pentium[®] II Xeon[™] Processor Specification Update

Release Date: March 2001

Order Number: 243776-030

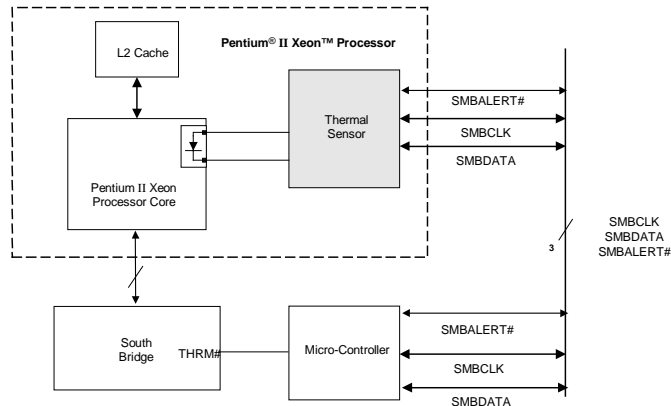
Figure 1. An Example of Microcontroller Driven Thermal Management

D30. Thermal Sensor May Assert SMBALERT# Incorrectly

Problem: The Pentium II Xeon processor has a thermal sensor that monitors the processor core's temperature. The thermal sensor asserts SMBALERT# if the processor temperature exceeds the temperature limits set in the Alarm Threshold Registers (T_{HIGH} , T_{LOW}). It also sets the corresponding Status Register bits to identify the cause of the interrupt. Figure 1 gives one example of the how the SMBALERT# signal could be used in a system.

Under the conditions described below, the thermal sensor incorrectly generates the SMBALERT# interrupt. *All* of the following conditions must be met to trigger a false interrupt:
