# Mobile Pentium® II Processor Specification Update

Release Date: January 25, 1999

Order Number: 243887-007

The Mobile Pentium® II processor or the Intel® Pentium II Processor Mobile Module may contain design defects or errors known as errata which may cause the product to deviate from published specifications. Current characterized errata are documented in this Specification Update.

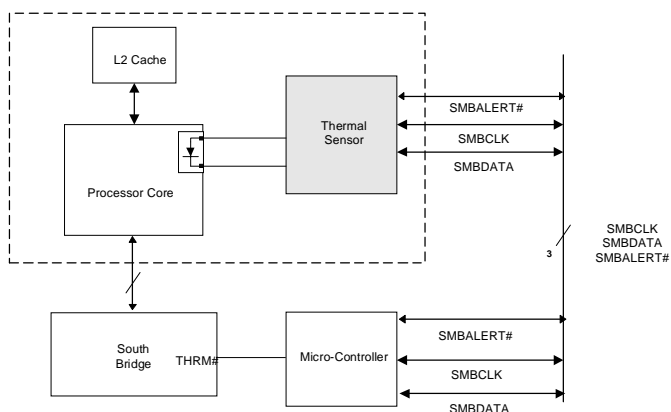
**Figure 1. An Example of Microcontroller Driven Thermal Management**

## **B30. Thermal Sensor May Assert SMBALERT# Incorrectly**

**PROBLEM:** The Mobile Pentium II processor and the Pentium II Processor Mobile Module have a thermal sensor that monitors the processor core's temperature. Please note that desktop systems could have a similar thermal device. The thermal sensor asserts SMBALERT# if the processor temperature exceeds the temperature limits set in the Alarm Threshold Registers (T<sub>HIGH</sub>, T<sub>LOW</sub>). It also sets the corresponding Status Register bits to identify the cause of the interrupt. Figure 1 gives one example of the how the SMBALERT# signal could be used in a system.

Under the conditions described below, the thermal sensor incorrectly generates the SMBALERT# interrupt. *All* of the following conditions must be met to trigger a false interrupt:
