Mobile Intel[®] Pentium[®] II Processor Specification Update

Release Date: November 2001

Order Number: 243887-035

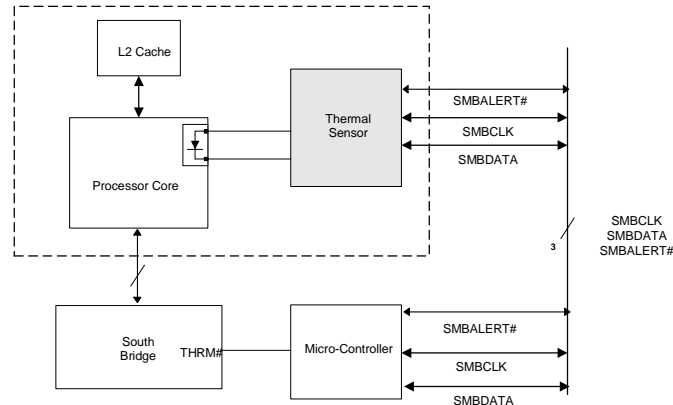
Figure 1. An Example of Microcontroller Driven Thermal Management

B30. Thermal Sensor May Assert SMBALERT# Incorrectly

Problem: The Mobile Pentium II processor and the Pentium II Processor Mobile Module have a thermal sensor that monitors the processor core's temperature. Please note that desktop systems could have a similar thermal device. The thermal sensor asserts SMBALERT# if the processor temperature exceeds the temperature limits set in the Alarm Threshold Registers (T_{HIGH} , T_{LOW}). It also sets the corresponding Status Register bits to identify the cause of the interrupt. Figure 1 gives one example of the how the SMBALERT# signal could be used in a system.

Under the conditions described below, the thermal sensor incorrectly generates the SMBALERT# interrupt. *All* of the following conditions must be met to trigger a false interrupt:
