# Intel<sup>®</sup> 82576EB Gigabit Ethernet Controller Specification Update

LAN Access Division (LAD)

Revision 2.84  
January 2012

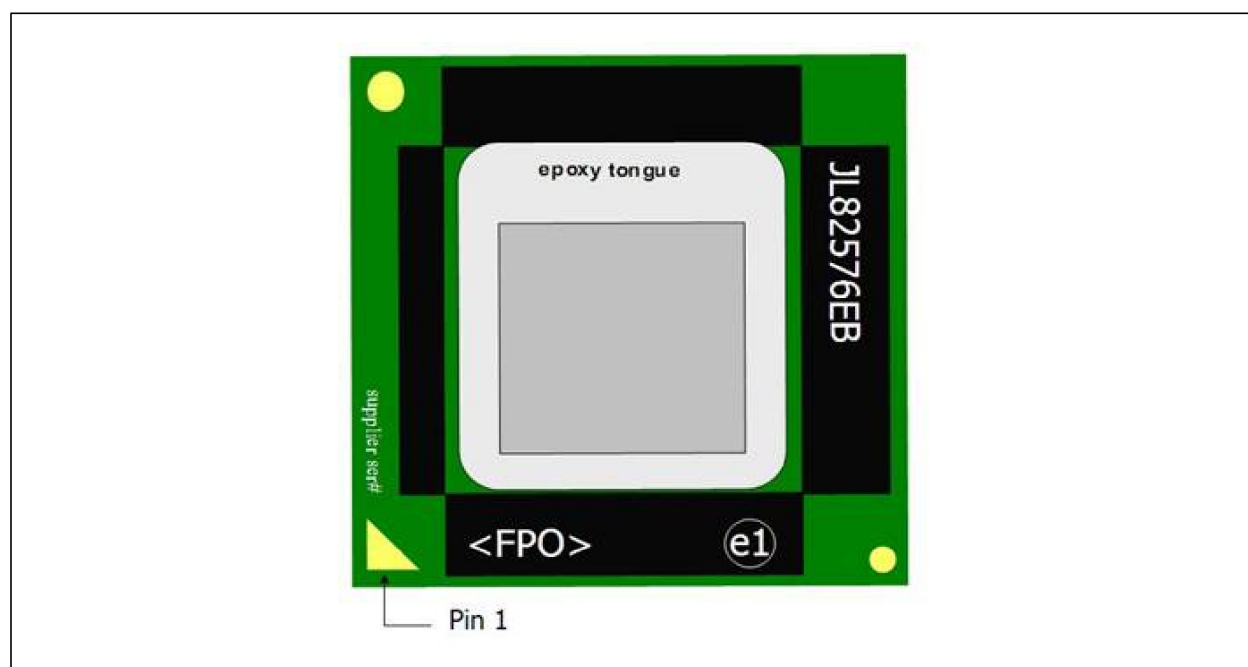
### 1.30 Marking Diagram

Figure 1. Example With Identifying Marks

Lead-free parts will have "JL" as the prefix for the product code (vs. "HL").
