# **Intel® 82580EB/82580DB Gigabit Ethernet Controller Specification Update**

**Networking Division (ND)**

Revision 2.7  
February 2020

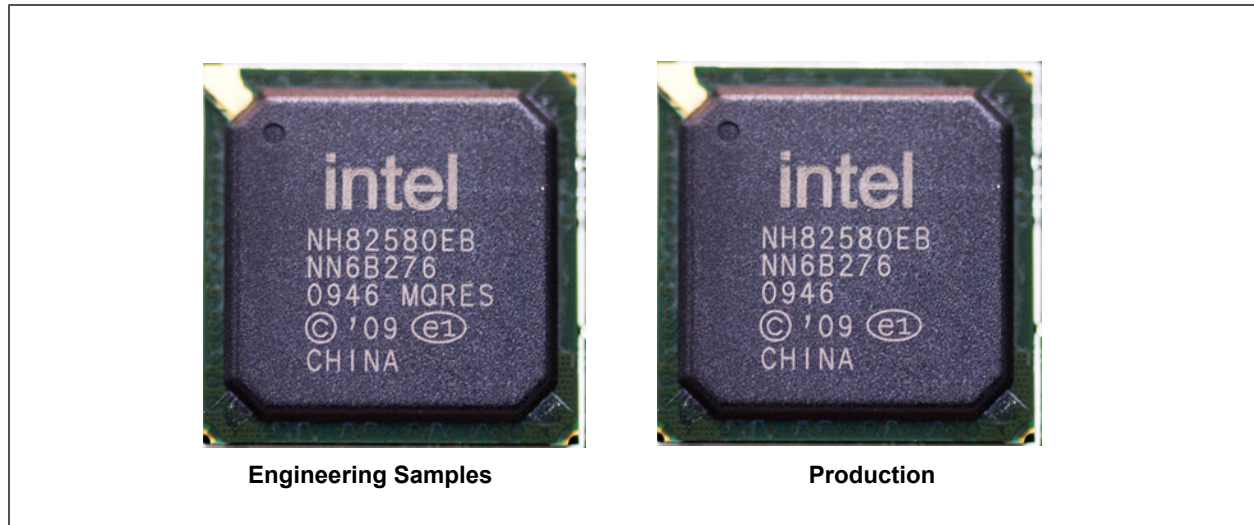
**Figure 1. Sample Component Diagram Illustrating Identifying Marks**

Refer to [Figure 1](#):
