82545GM Gigabit Ethernet Controller Specification Update

June 6, 2006

The 82545GM Gigabit Ethernet Controller may contain design defects or errors known as errata that may cause the product to deviate from published specifications. Current characterized errata are documented in this Specification Update.

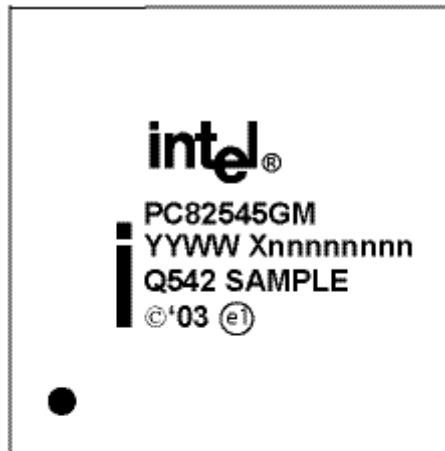
Lead-Free Device

Note: The black dot in the lower left-hand corner denotes pin 1.

Product	Stepping	QDF Number	Top Marking	Notes
82545GM	A0	Q522	RC82545GM	Engineering Samples
82545GM	A1	Q536	RC82545GM	Engineering Samples
82545GM	A1	-	RC82545GM	Production
82545GM	A1	-	PC82545GM	Lead-Free Production
