***82547GI/82547EI***  
***Gigabit Ethernet Controller***  
***Specification Update***

*June 23, 2006*

The 82547GI/82547EI Gigabit Ethernet Controller may contain design defects or errors known as errata that may cause the product to deviate from published specifications. Current characterized errata are documented in this Specification Update.

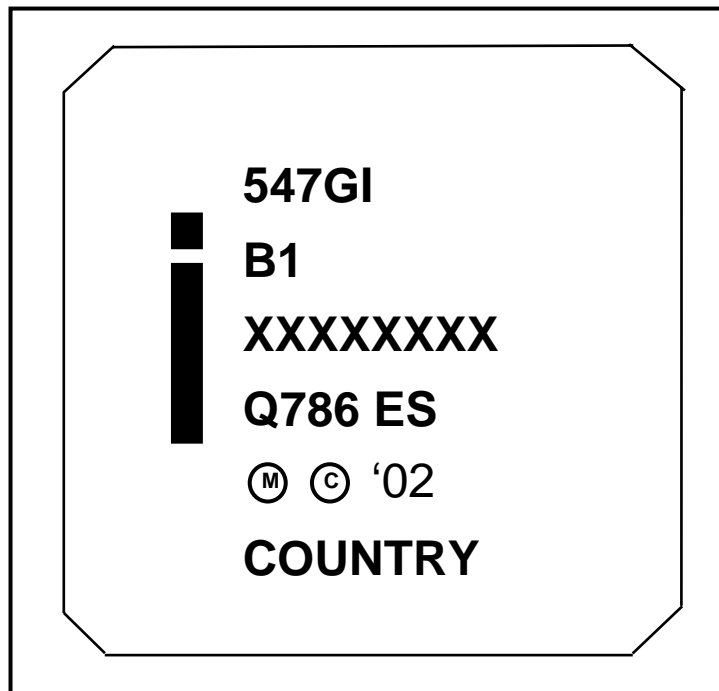
### 82547GI/82547EI COMPONENT MARKING INFORMATION

Product	Stepping	QDF Number	Top Marking	Notes
82547EI	A0	Q 520	547EI	Engineering Samples
82547EI	A1	Q777	547EI	Engineering Samples
82547EI	B0	Q779	547EI	Engineering Samples
82547EI	B0		82547EI	Production Units
82547GI	B1	Q786	547EI or 547GI	Engineering Samples
82547GI	B1		547GI	Production Units

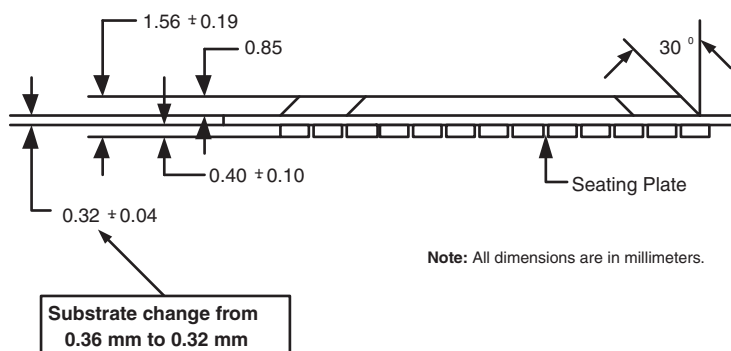
**Implication:** This migration allows flexibility with new substrate suppliers to support Intel demands on PBGA.

This migration does not affect fit, form, or function.
