Intel[®] 82599 10 GbE Controller

Specification Update

Ethernet Products Group (EPG)

Revision 4.3
331521-012

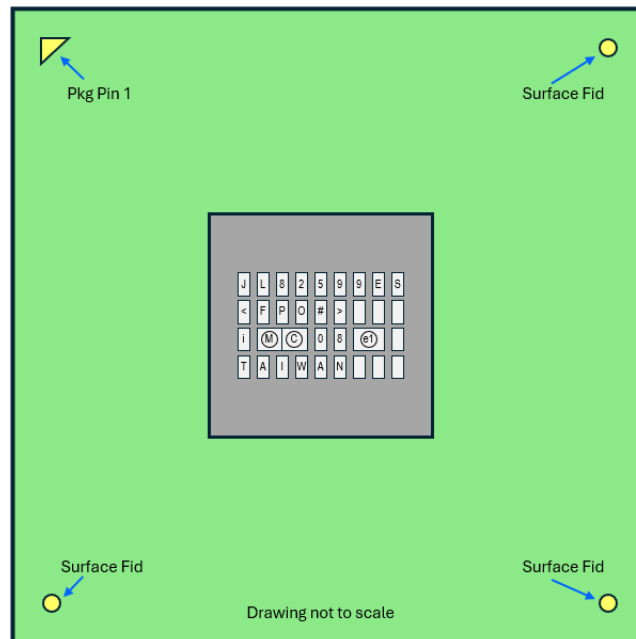
Figure 1-3. Package Marketings After PCN 117151

Lead-free parts will have "JL" as the prefix for the product code.

The "S" designator refers to the specification number. See [Table 1-1](#).

Revision	Date	Comments
4.3	July 3, 2024	Product Code and Device Identification added: <ul style="list-style-type: none"> Figure 1-2 (Added) Figure 1-3 (Added)
