# Intel<sup>®</sup> Ethernet Controller X550

Specification Update

Revision 3.0  
333717-010

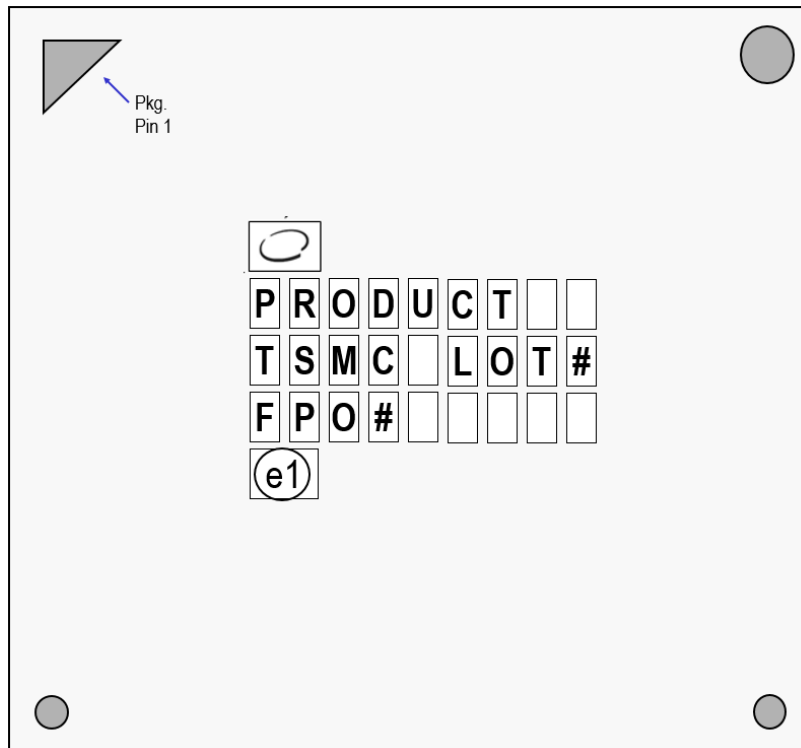
**Figure 1-1. X550-AT2**

- LINE1: Swirl Logo
- LINE2: Product code
- LINE3: TSMC LOT#
- LINE4: FPO# Trace code
- LINE5: Pb-free mark

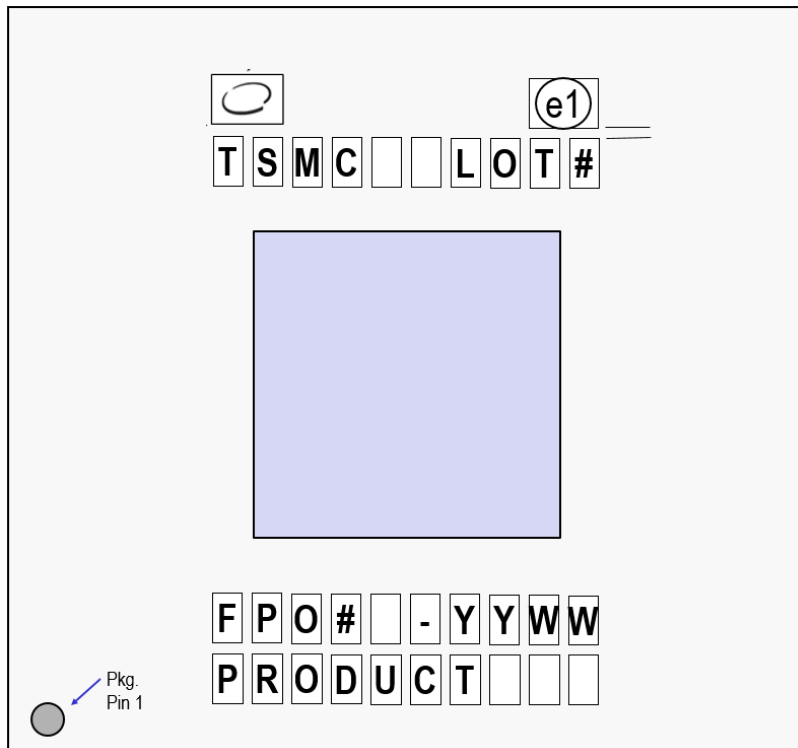
**Figure 1-2. X550-BT2**

- GRP1LINE1: Swirl Logo, Pb-Free
- GRP1 LINE2: TSMC Lot#
- GRP2LINE1: FPO# YYWW
- GRP2LINE2: Product Code
