Intel[®] Celeron[™] Processor Specification Update

Release Date: November 1999

Order Number: 243748-019

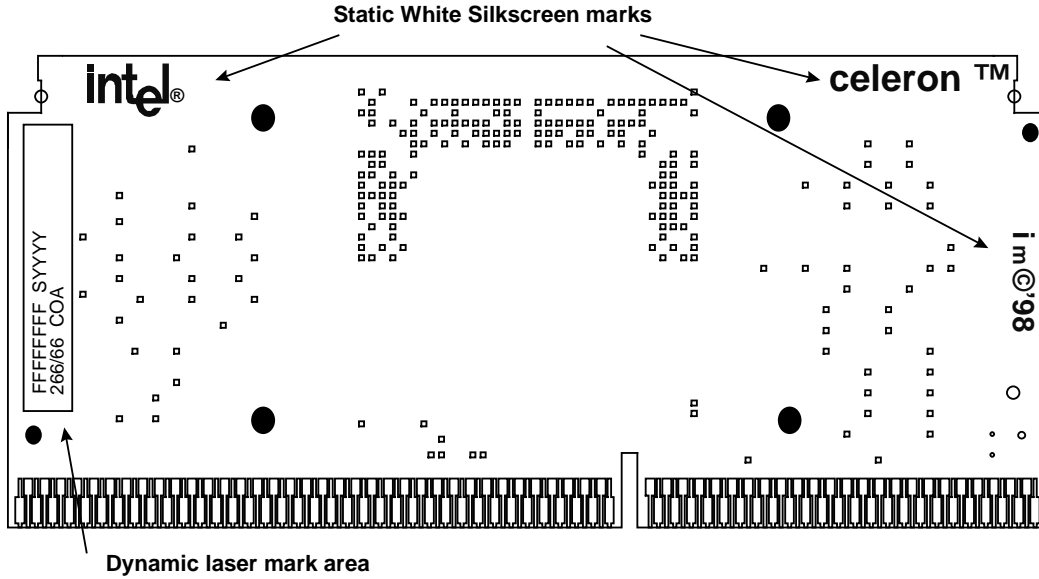
Intel® Celeron™ Processor and Boxed Intel® Celeron™ Processor Markings (S.E.P. Package)

- SYYY = S-spec Number.
- FFFFFFFF = FPO # (Test Lot Traceability #).
- COA = Country of Assembly.

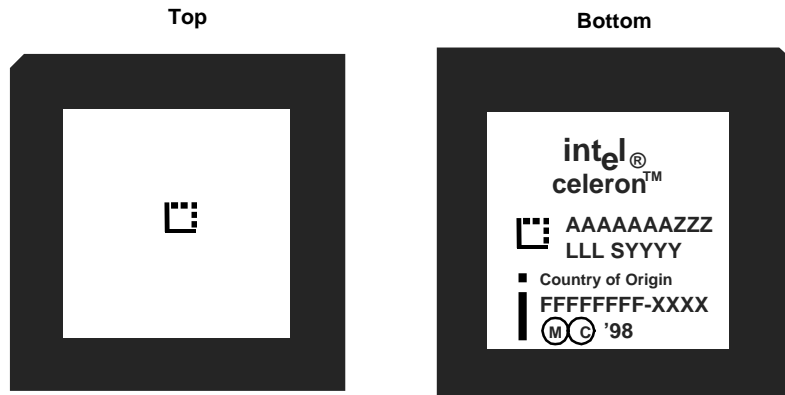
Intel® Celeron™ Processor and Boxed Intel® Celeron™ Processor Markings (PPGA Package)

- AAAAAA = Product Code
- ZZZ = Processor Speed (MHz)
- LLL = Integrated Level-Two Cache Size (in Kilobytes)
- SYYYY = S-Spec Number
- FFFFFFFF-XXXX = Assembly Lot Tracking Number
