Pentium® II Processor Specification Update

Release Date: November 1999

Order Number: 243337-031

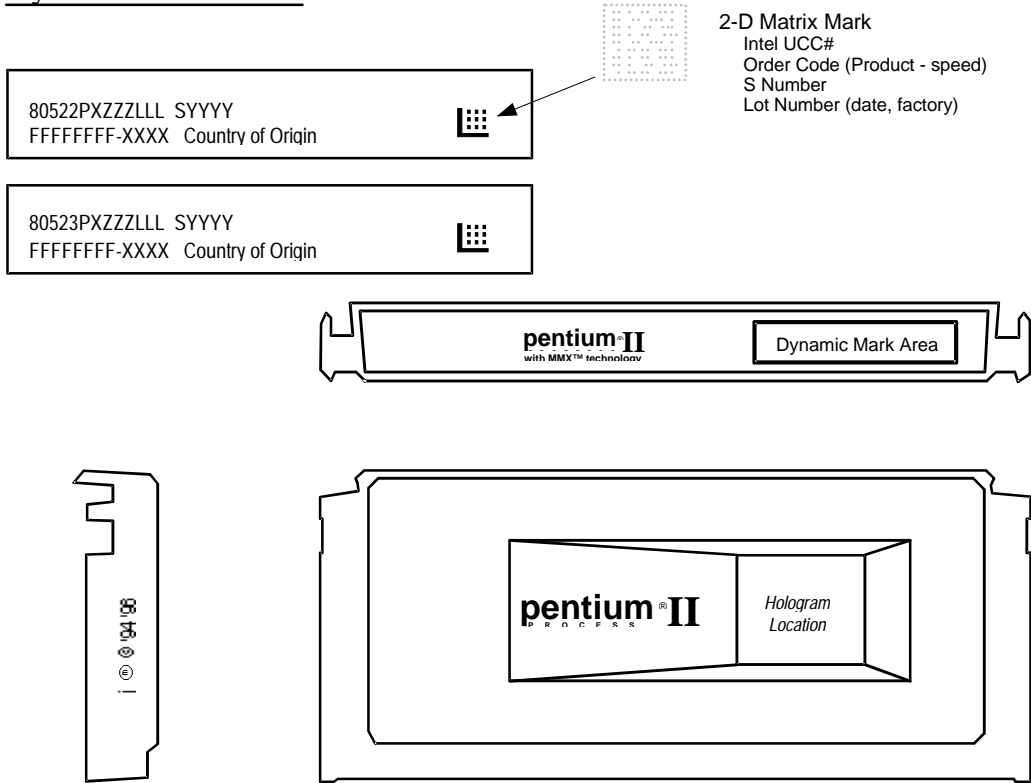
Pentium® II Processor Markings

Dynamic Mark Area

- ZZZ = Speed (MHz).
- SYYYY = S-spec Number.
- LLL = Level 2 Cache Size (in Kilobytes).
- FFFFFFFFF = FPO # (Test Lot Traceability #).
- XXXX = Serialization Code.
