IA-32 Intel[®] Architecture Software Developer's Manual

Documentation Changes

November 2003

Document Number: 252046-006

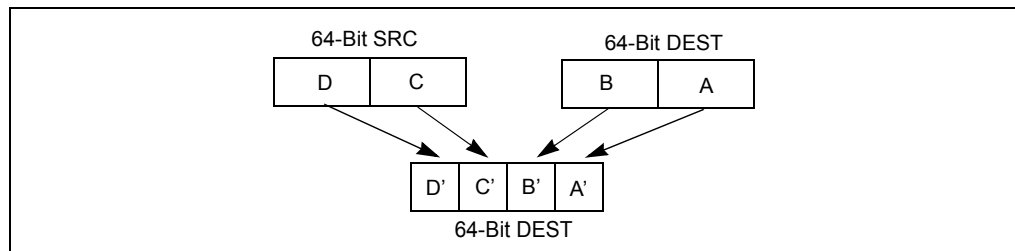
Figure 3.6. Operation of the PACKSSDW Instruction Using 64-bit Operands

Operation of the PACKSSDW instruction was incorrectly illustrated in Figure 3-6, the “PACKSSWB/PACKSSDW—Pack with Signed Saturation” section, Chapter 3, *IA-32 Intel Architecture Software Developer’s Manual, Volume 2*.

The corrected figure is reproduced below.

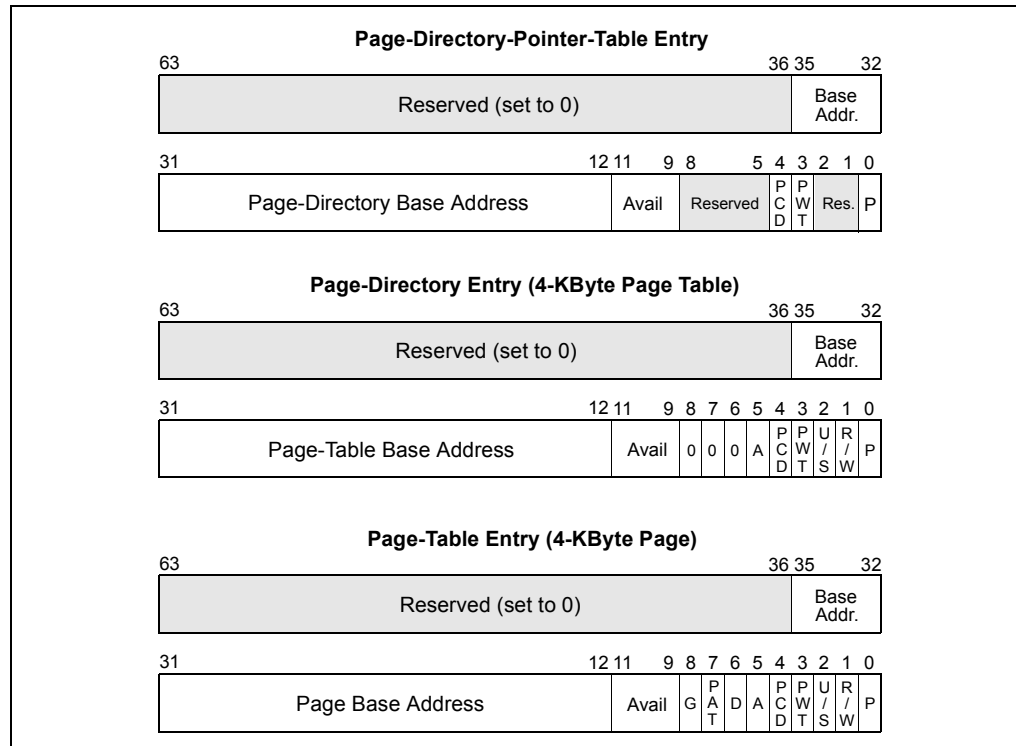
Figure 3-20. Format of Page-Directory-Pointer-Table, Page-Directory, and Page-Table Entries for 4-KByte Pages with PAE Enabled

In Figure 3-20 and 3-21, located in the “Page-Directory and Page-Table Entries With Extended Addressing Enabled” section, Chapter 3, *IA-32 Intel Architecture Software Developer’s Manual, Volume 3*; Bit 0 of both representations of the Page-Directory-Pointer-Table Entry now indicate P (showing the the location of the ‘present flag’ bit).

The corrected tables are reproduced below.

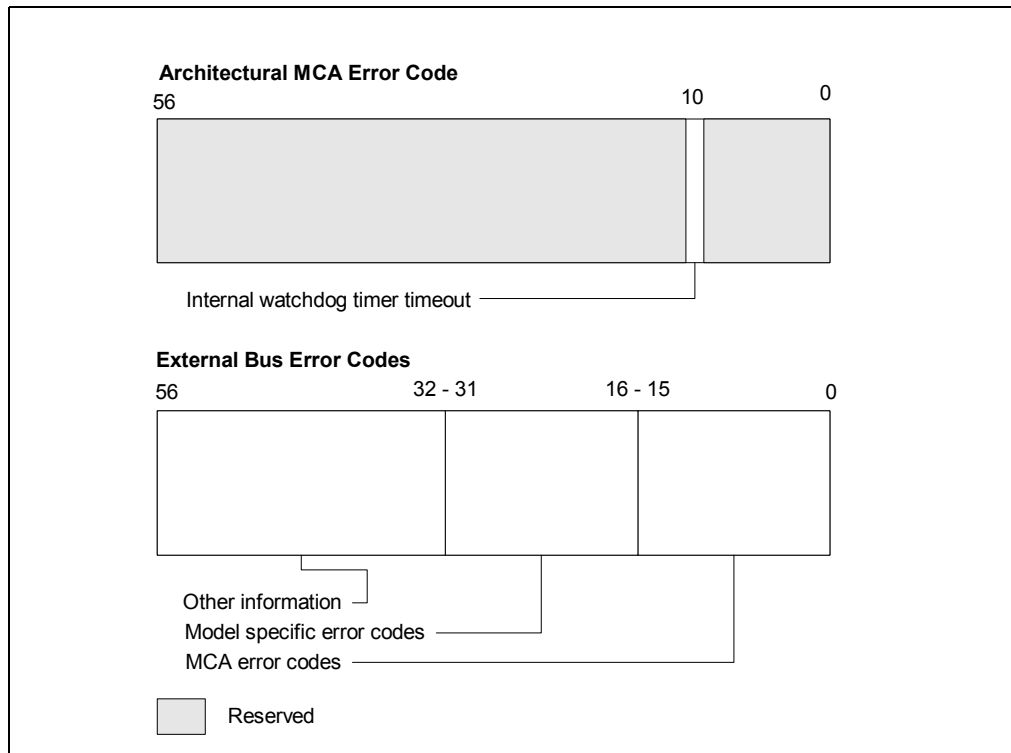
Figure E-1. IA32_MCi_STATUS Encoding for Family 06H

Machine error code reporting by processor family 06H is based on values read from IA32_MCi_STATUS (Figure E-1).

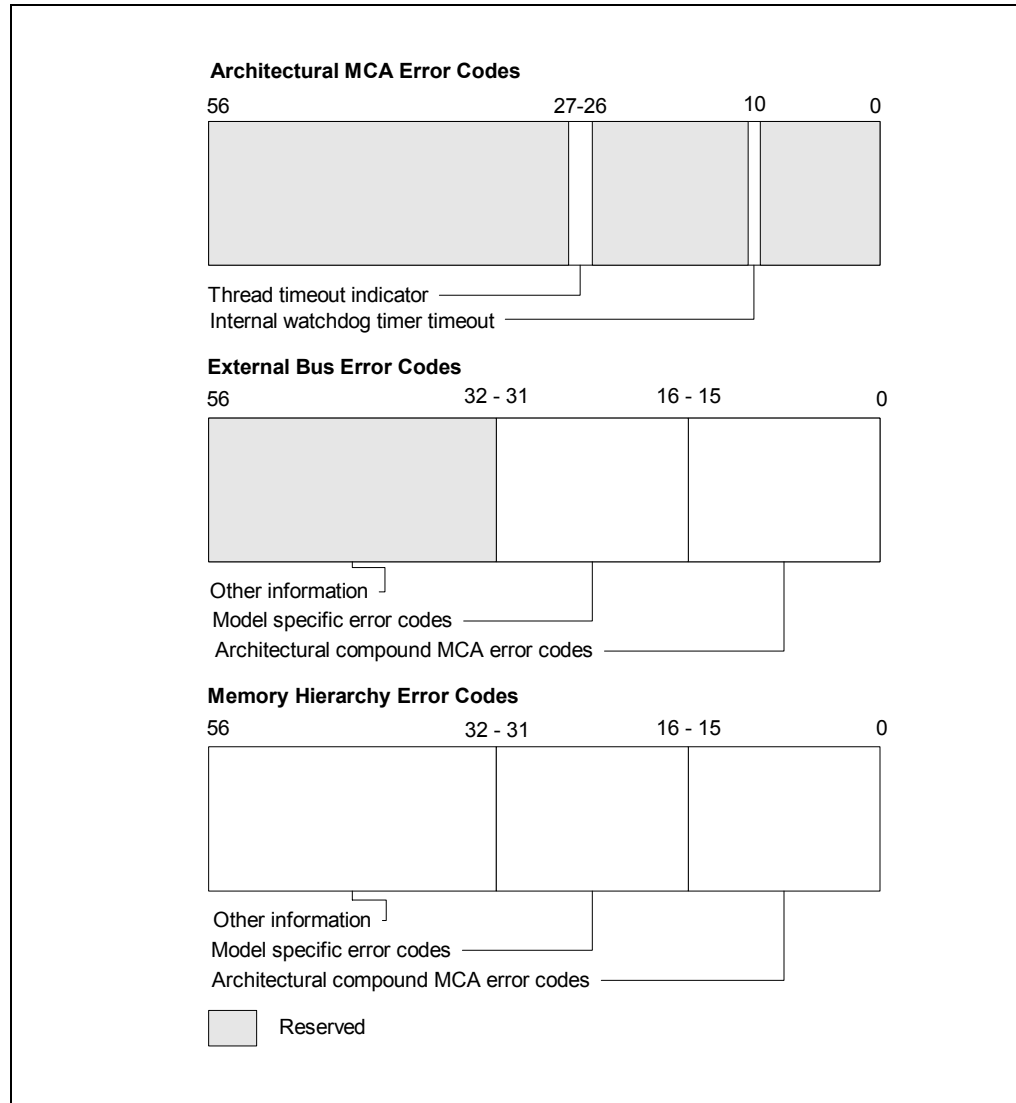
Figure E-2. IA32_MCI_STATUS Encoding for Family 0FH

Machine error code reporting by processor family 0FH is also based on values read from IA32_MCI_STATUS (Figure E-2).

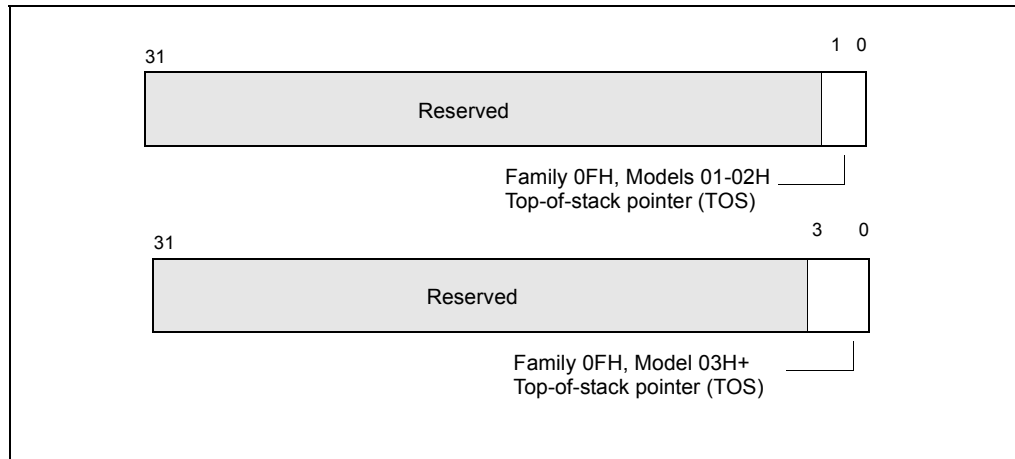
Figure 15-3. MSR_LASTBRANCH_TOS MSR Layout for the Pentium 4 and Intel Xeon Processor Family

See also: Table 15-2, Figure 15-3, and Figure 15-4 below.

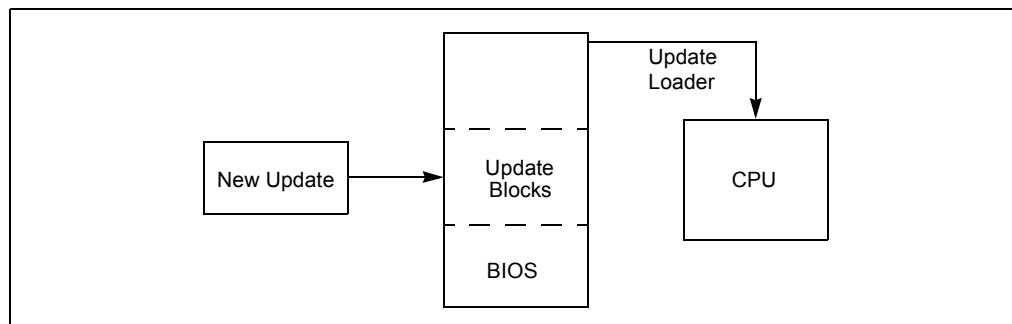
Figure 9-7. Applying Microcode Updates

A microcode update is used to correct errata in the processor. The BIOS, which has an update loader, is responsible for loading the update on processors during system initialization (Figure 9-7). There are two steps to this process: the first is to incorporate the necessary update data blocks into the BIOS; the second is to load update data blocks into the processor.

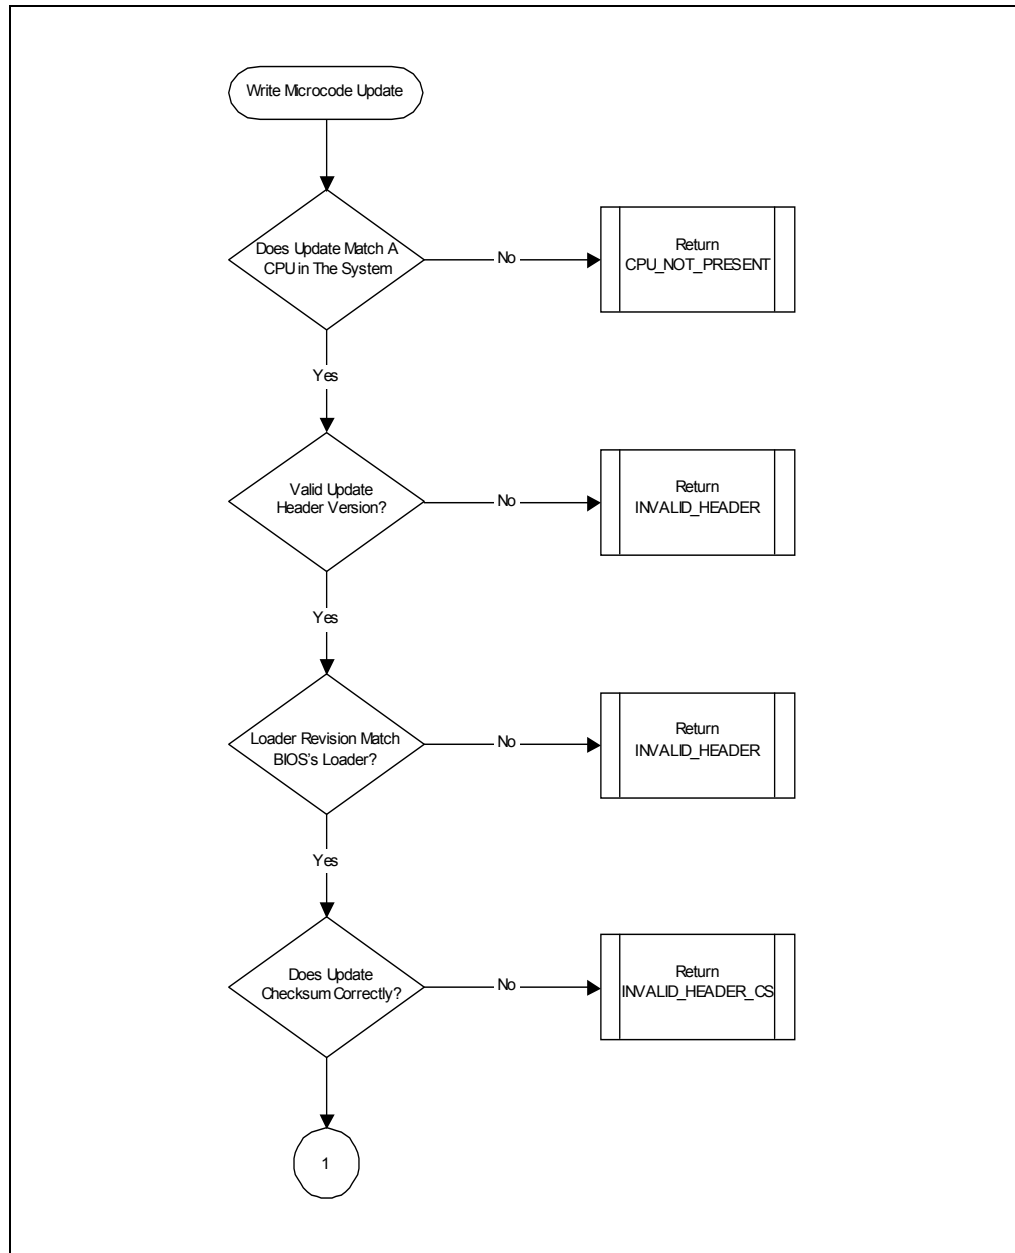
Figure 9-8. Microcode Update Write Operation Flow [1]

Figure 9-8 and Figure 9-9 show the process the BIOS follows to choose an update block and ensure the integrity of the data when it stores the new microcode update.

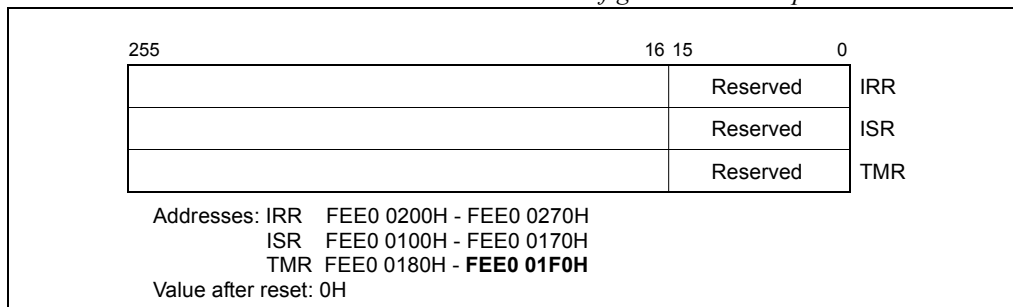
Figure 8-20. IRR, ISR and TMR Registers

In Volume 3 of the IA-32 Intel Architecture Software Developer's Manual, Chapter 8, Figure 8-22; an incorrect address has been corrected. The corrected figure has been reproduced below.

28. Figure 8-22 Has Been Corrected

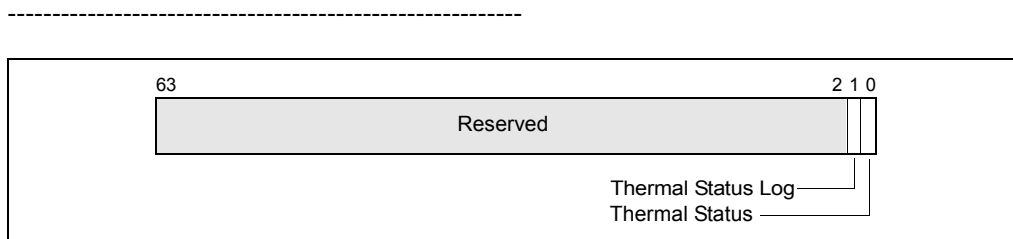
Figure 8-21. IA32_THERM_STATUS MSR

Thermal Status Log flag, bit 1
